Inspection of Selected Gear Reducers

ABC Steel – Anytown, IN Hot Mill

Work performed April 12, 2017
ABC Steel Purchase Order # **xxxxxxx**
Cage Gear Project # **1704011**

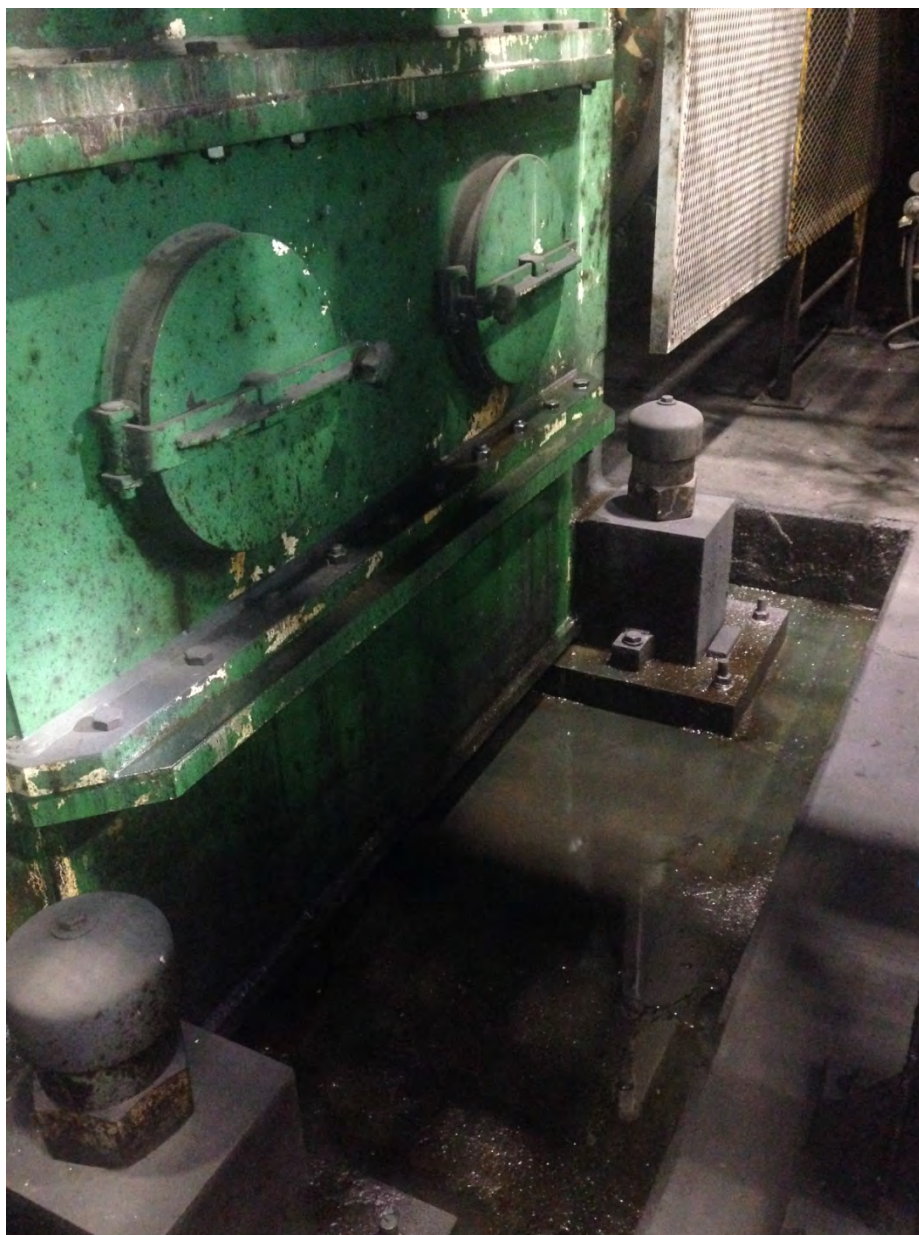
The first thing noted was the seemingly large amount of leakage and pools of oil around the unit. Upon further inspection, for the most part the bores and splits of the housing look okay. The suspicion is that the oil is seeping, when the unit is in operation, from the access doors on either side of the unit. An enhanced sealing system would likely reduce the amount of leakage from this unit.

Oil pooling around the base of the unit

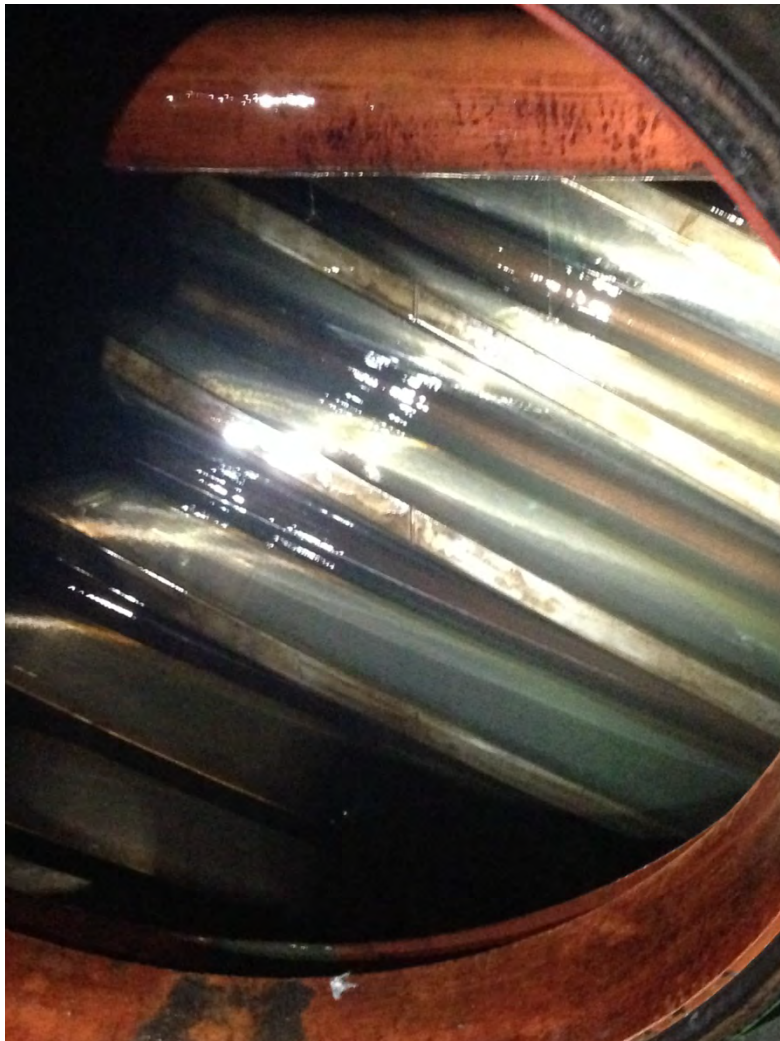
The Gear Mesh between the Bottom Shaft and the Upper Shaft looked good, with contact spaced evenly across the entire profile of the drive flanks, except where the teeth were end-relieved by design. All four of the helixes looked good on these double helical Pinion Shafts with no signs of pitting, spalling, plastic-flow or any other discontinuities. These gears exhibited normal, expected wear for the age and use of this unit.

Representative view of the Bottom Teeth of the F1 Pinion Stand

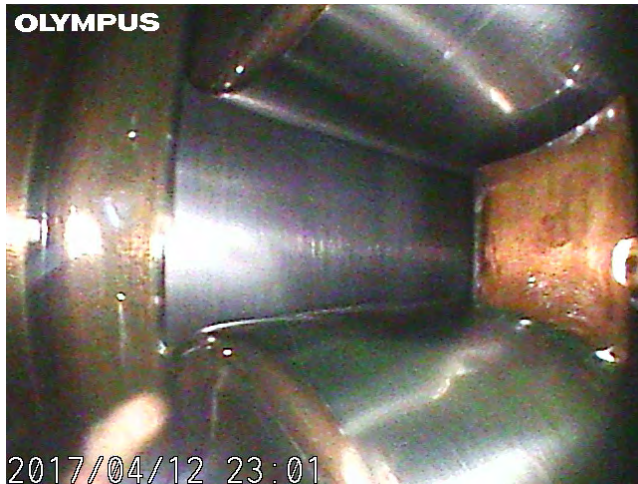
F1 Bottom Motor Side Bearing

Additionally, the Bearings for this unit also looked pristine on both the Motor Side and the Mill Side of this Reducer.

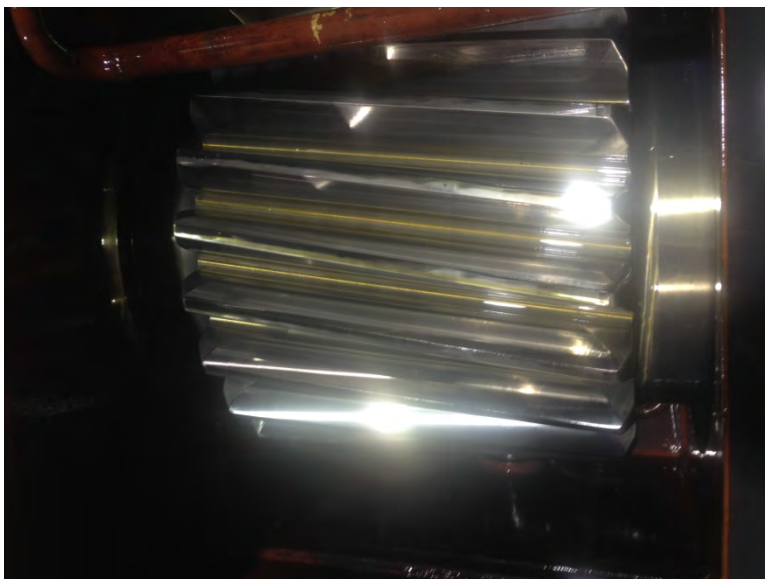
The Gear Mesh looked good with well proportioned contact between the elements.

MD1 Pinion Teeth.

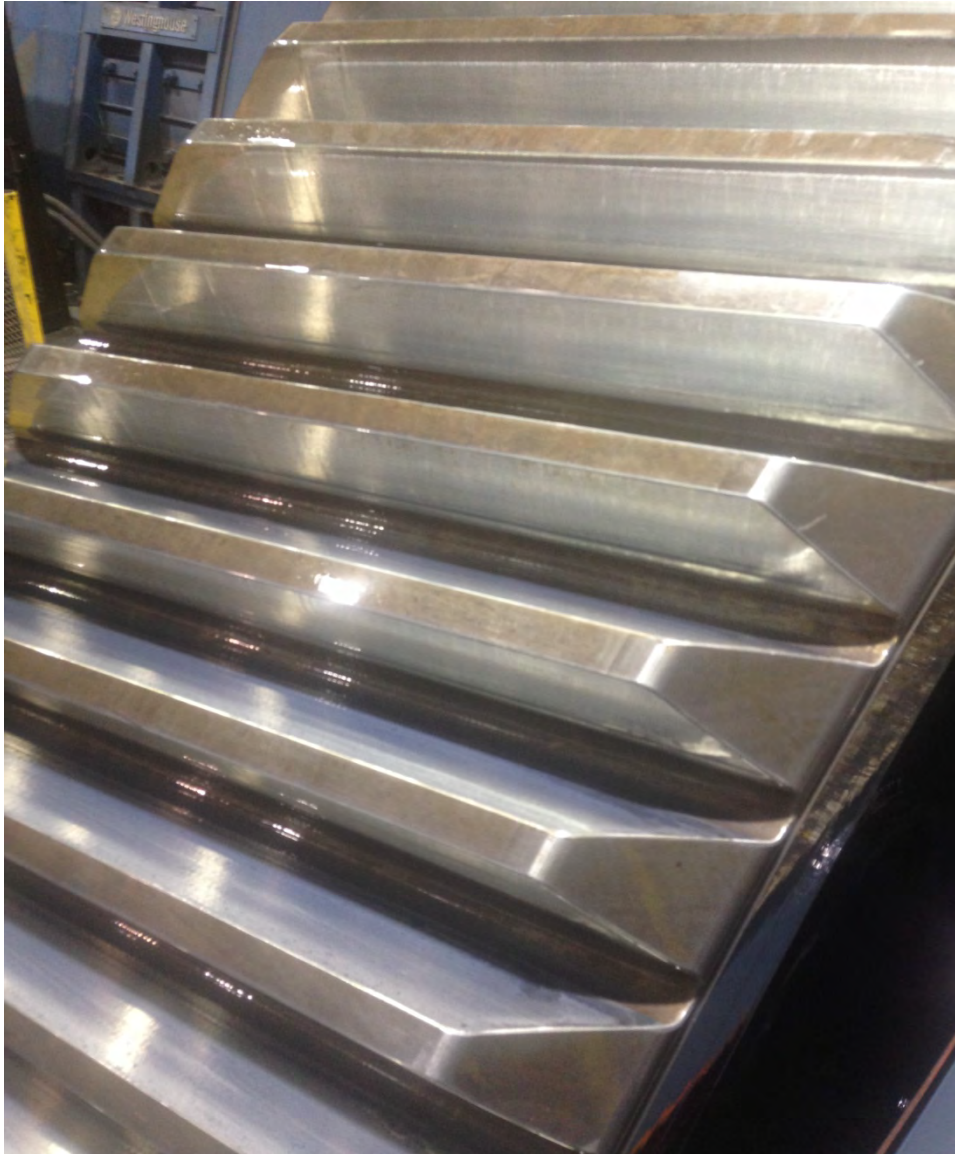
It was noticed on the Gear that, sometime in the past, something must have gone through the mesh as there is a blemish on every tooth that we could observe near the mill-side edge of the drive flank. These blemishes have been nicely hand-dressed and appear to pose no detriment to the operation of this gear set.

Notice the hand-dressed blemishes in the dedendum of the drive flank closest to us.

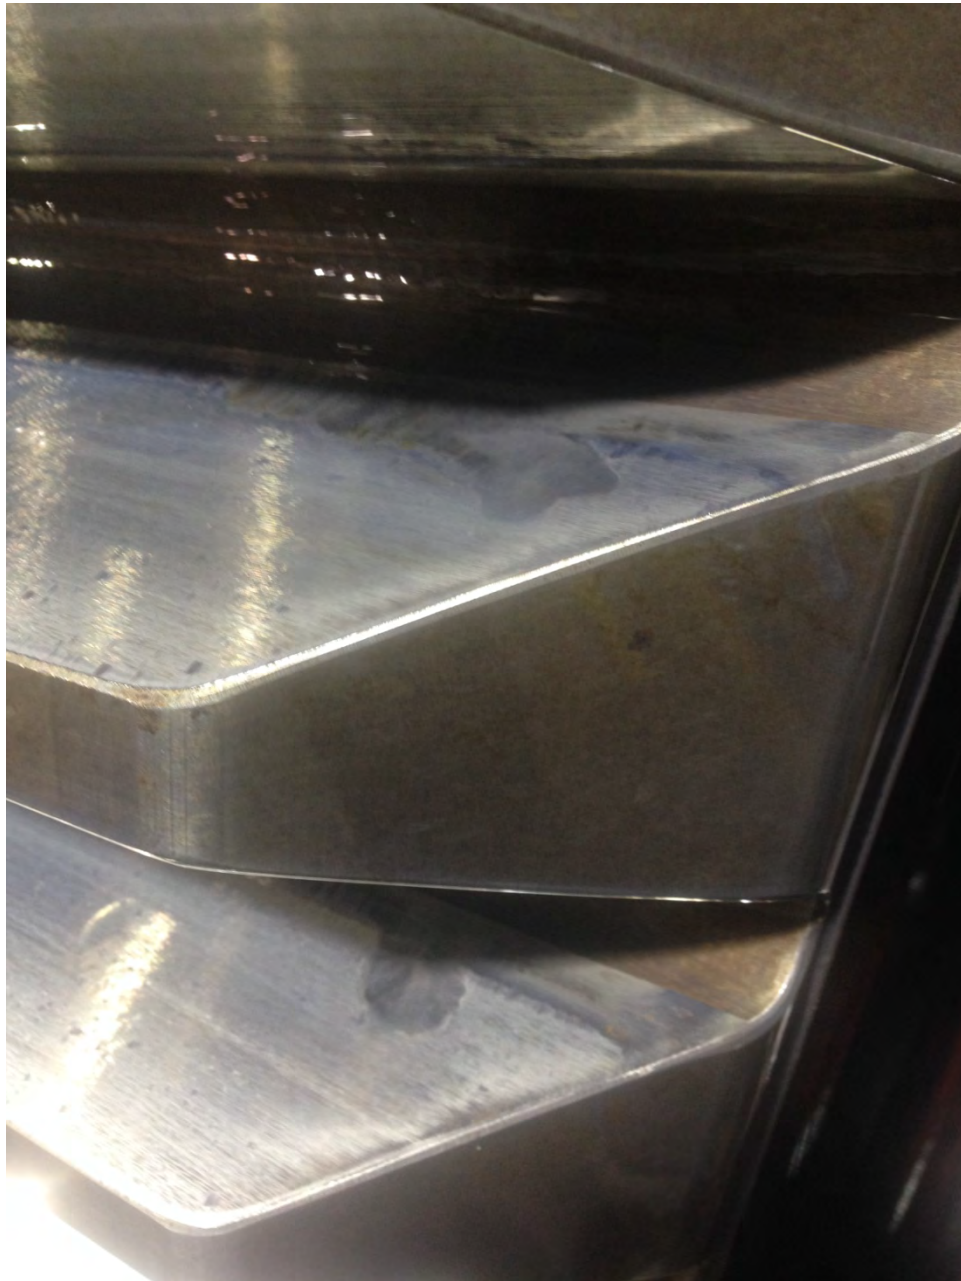
Close-up of the Gear Tooth blemishes on Main Drive 1

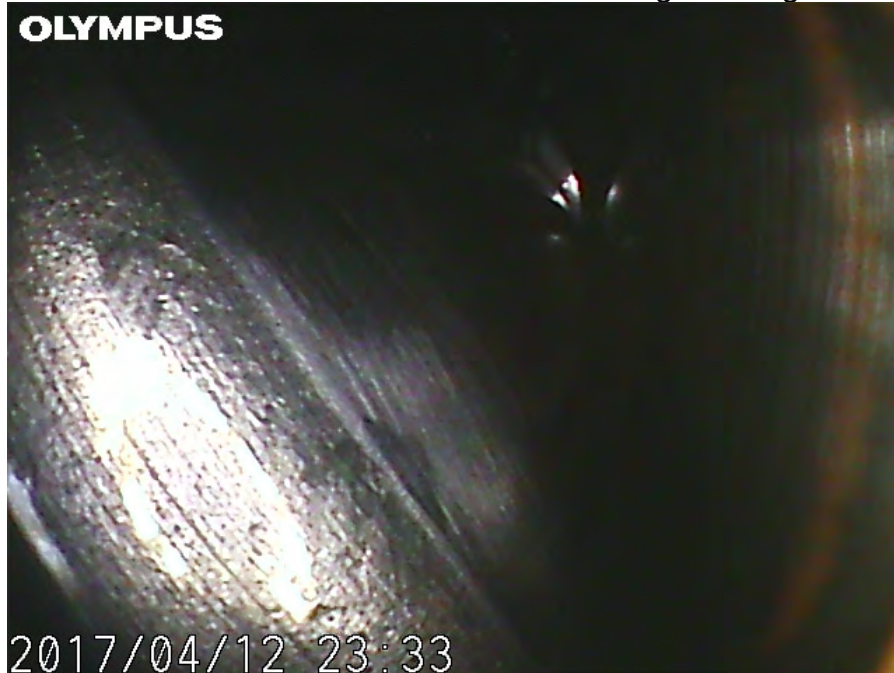
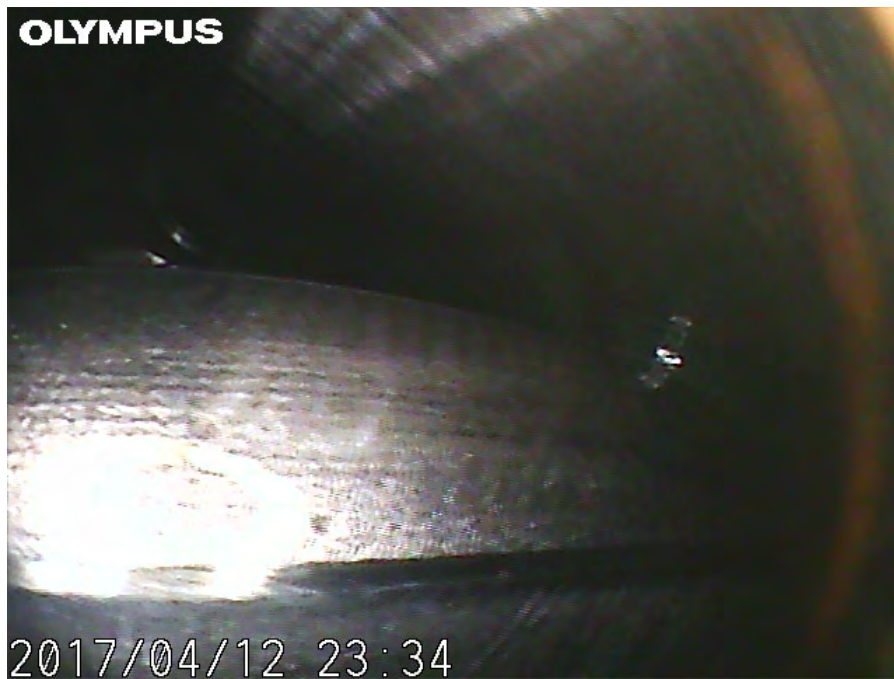
While the teeth looked good on Main Drive 1, there was an issue with the Mill Side Pinion Bearing. (The Motor Side Pinion Bearing looked good, as did both Bearings on the Gear.)

With the Bore Scope, we were able to observe some early and minor deterioration of the Race and the rollers. From the photographs, wear and rust are clearly visible.

Photos of Main Drive 1 Pinion Mill Side Bearing showing wear and rust.

The gear teeth of both elements both look as if they possess a significant amount of remaining useful life. While we do not believe that catastrophic failure is imminent, the Pinion Shaft Mill Side Bearing should be addressed sooner rather than later. It is best to take action on "Planned Outages" rather than on "Unplanned Outages".

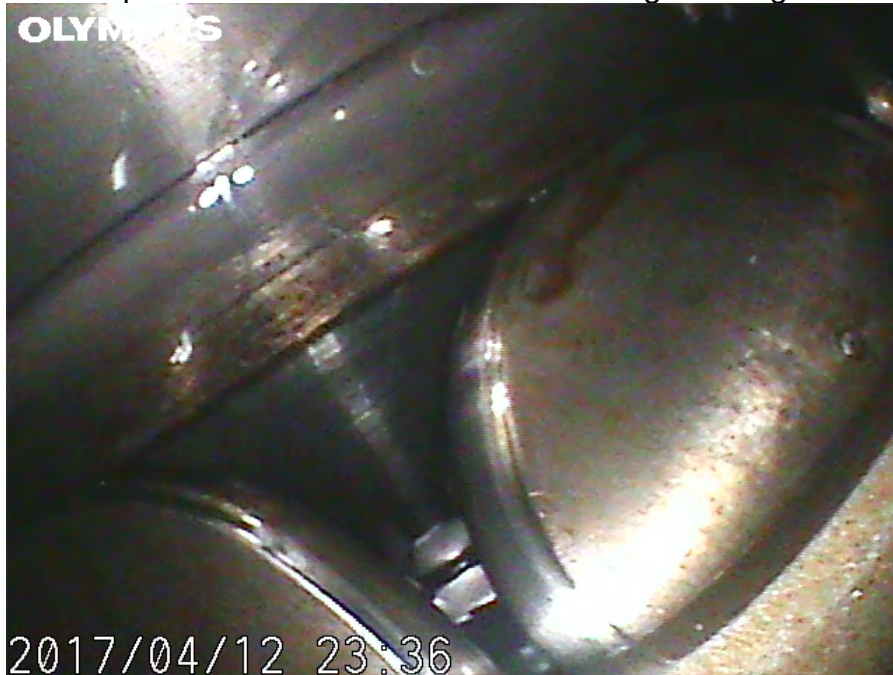
Another photo of MD1 Mill Side Pinion Bearing showing rust.

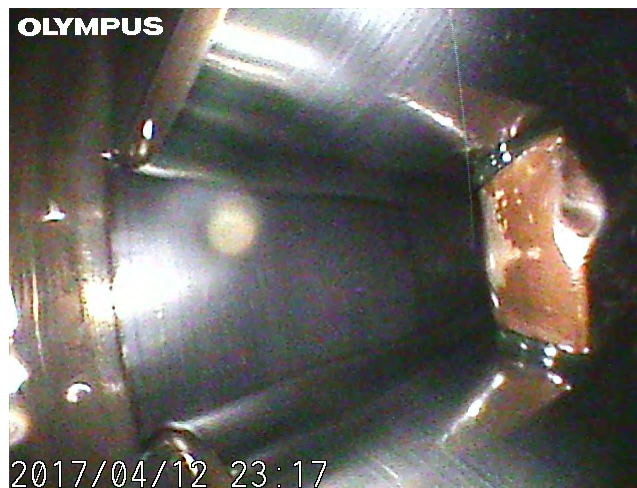
MD1 Motor Side Pinion Bearing

The other Bearings in the unit looked good as shown in the following representative photograph.

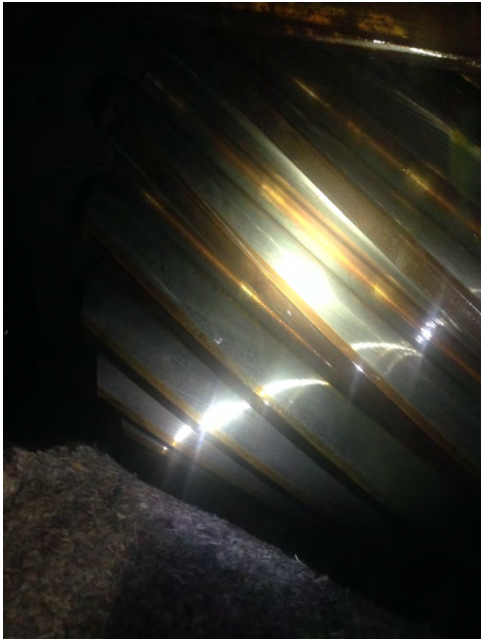
This unit displayed leakage similarly to the F1 Pinion Stand, just not as bad. The teeth on this unit also showed good contact and normal, expected wear. For some reason, there was a degree of discoloration associated with the teeth of both elements. Generally that indicates a “heat” issue but there were no other signs indicating issues. We detected no pitting, spalling or even plastic-flow on either the top or bottom Pinion Shaft.

F2 Bottom Teeth – Dis-Coloration ?

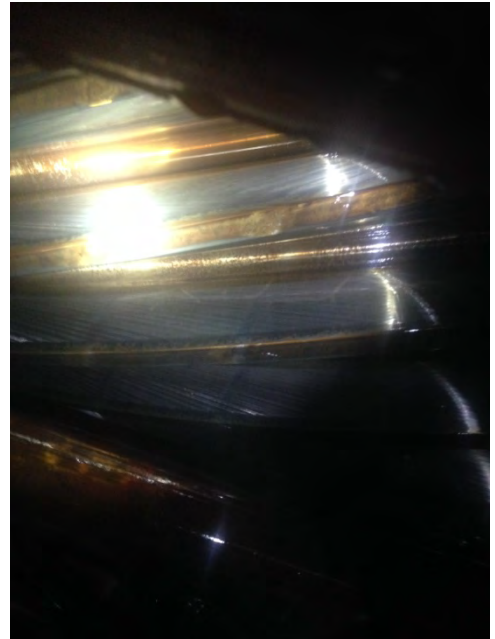
F2 Top Teeth – Dis-Coloration ?

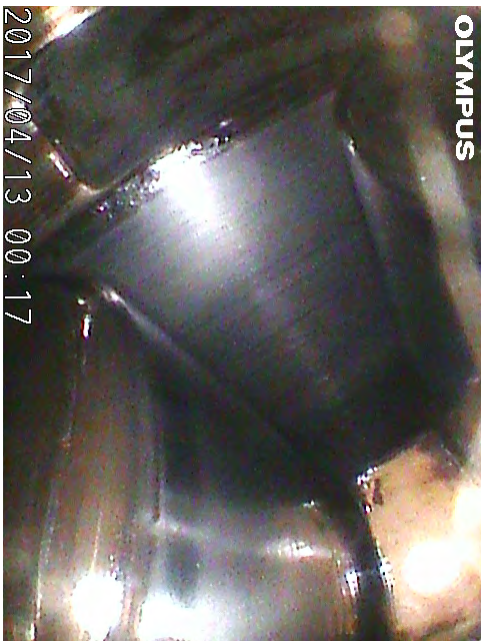
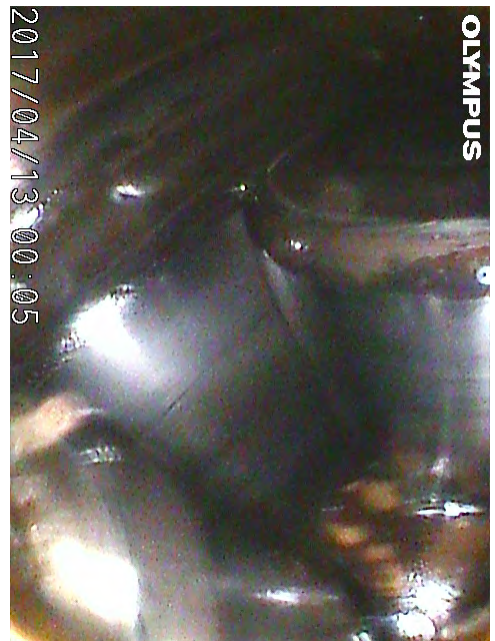
F2 Bottom Motor Bearings showing rust

The Pinion Shaft Teeth on both the Top and Bottom elements looked good, albeit showing some discoloration. The Motor Side Bearings on both the Top and Bottom Pinion Shafts are both showing signs of early stage deterioration. The Mill Side Bearings on both items look good. At this time, we cannot determine if this is new information or if this condition has existed for some longer period of time. We will look at the bearings again in six months to determine if the bearing wear is increasing or not.

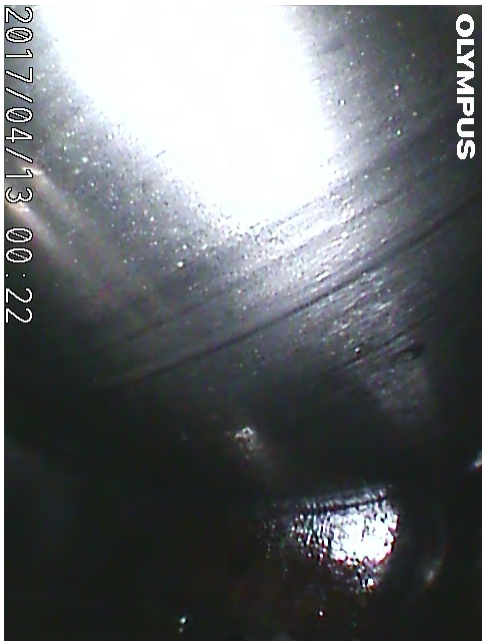
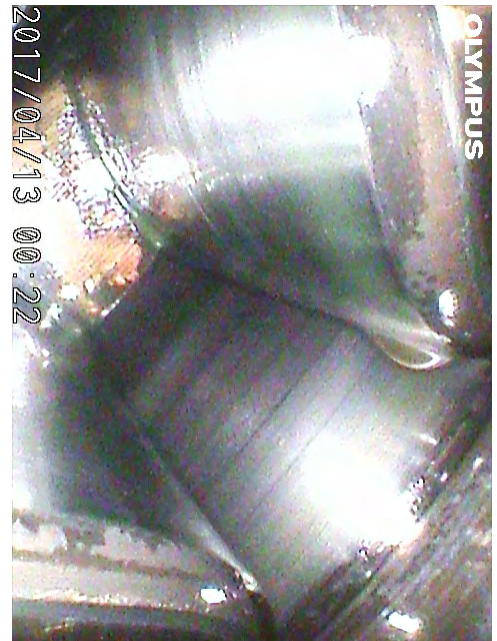
F2 Top Motor Side Bearings showing wear

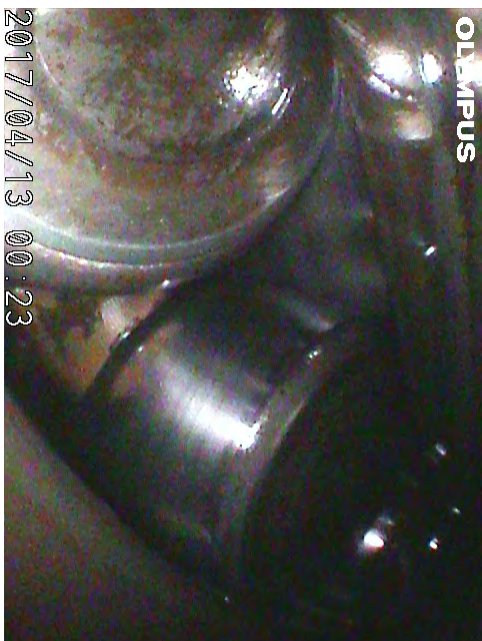
F2 Top Mill Side Bearing

Both F2 Mill Side Bearings, top and bottom, looked okay.

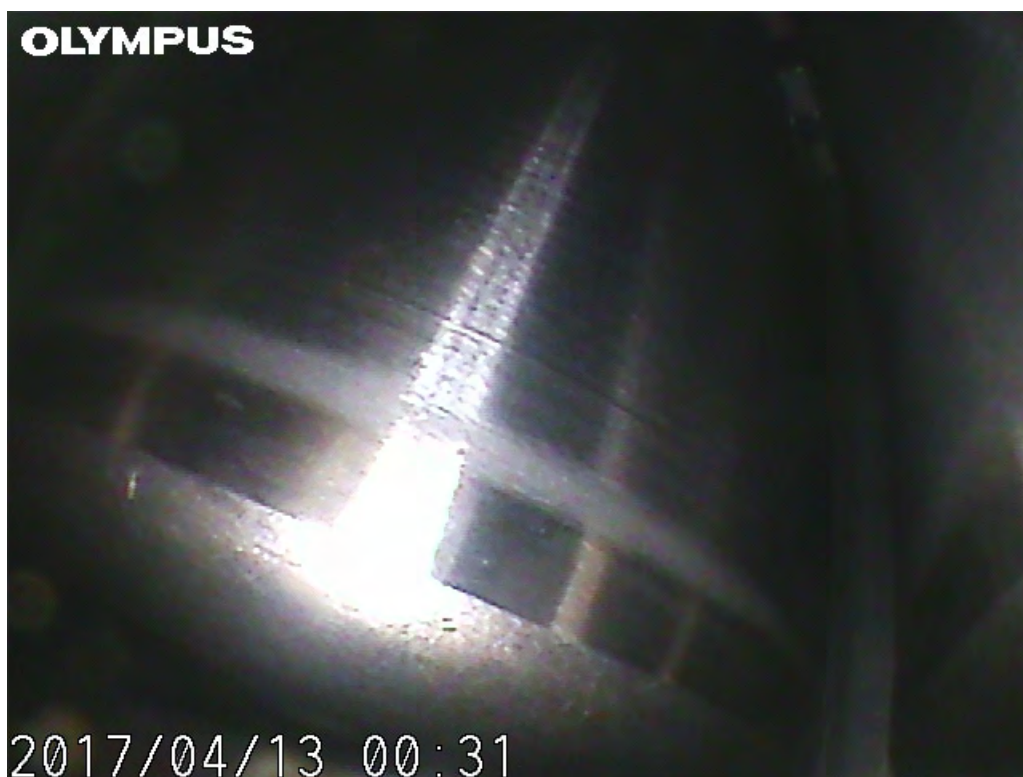
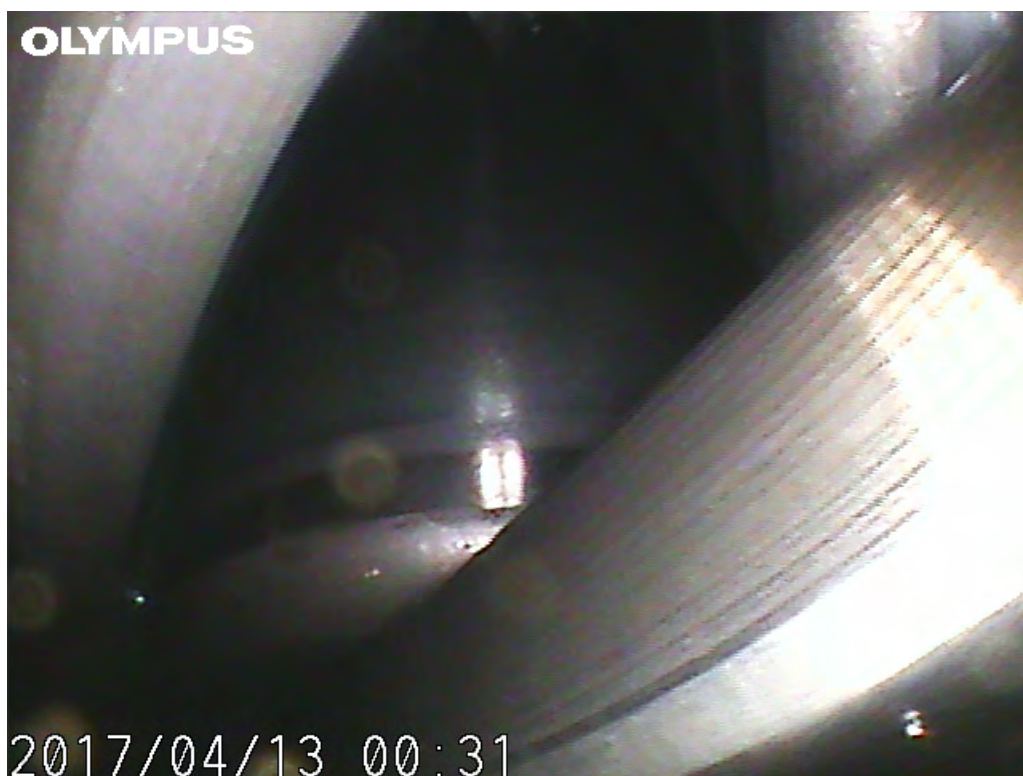
With regard to the **Main Drive # 2** Bearings, both of the Gear Bearings look good with no noticeable issues. The Pinion Shaft Motor Side Bearing also looks good with no issues. However, the **Pinion Shaft Mill Side Bearing** shows signs of early deterioration as the photographs below show.

As with the #1 Main Drive, the gear teeth of both of these elements both look as if they possess a significant amount of remaining useful life. While we do not believe that catastrophic failure is imminent, this Pinion Shaft Mill Side Bearing should also be addressed sooner rather than later. Again, we will look at this next time as well.

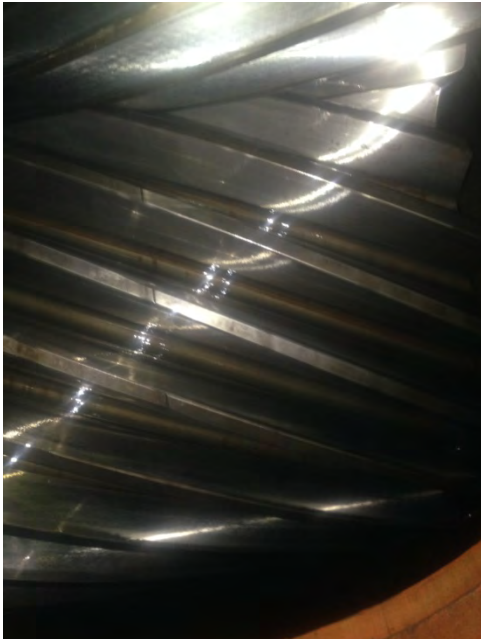
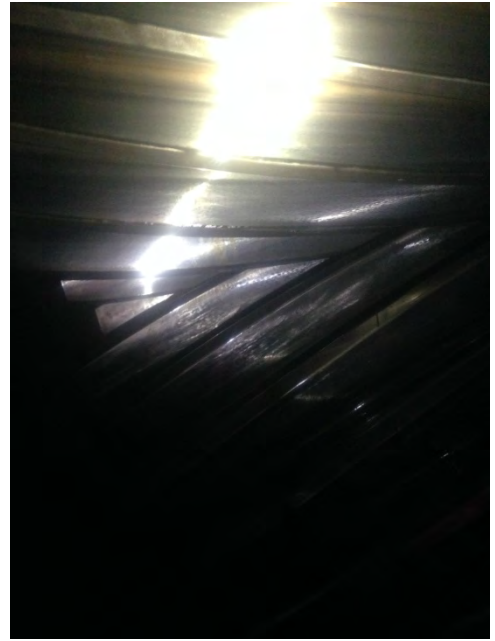
F3 Pinion Stand – Gear Meshes from both hands of the Pinion Shafts

The Teeth and the Bearings in this unit all look as they should with good, full contact between the elements. No issues were observed during our inspection.

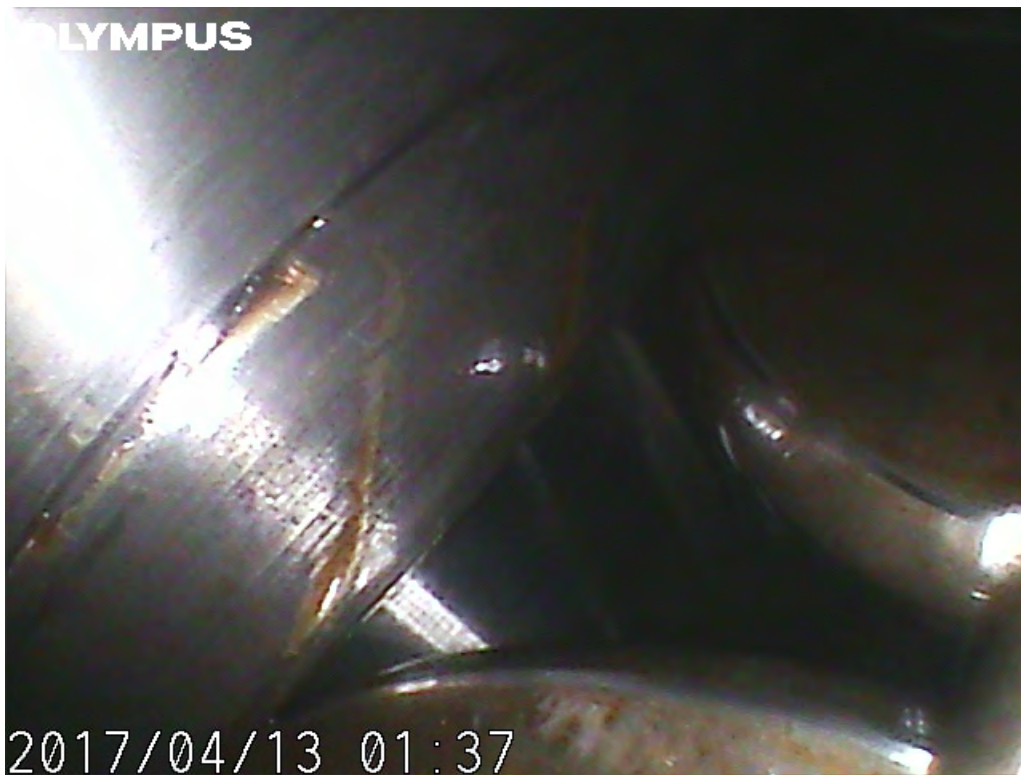
Main Drive #3 Gear Mill Side Bearing

(Note that there is a gouge in the Race of the Gear's Mill Side Bearing but it does not appear to be impacting the Rollers or performance of the item.)

Note the gouge in the Race that does not appear to be impacting the operation or performance of this Bearing.

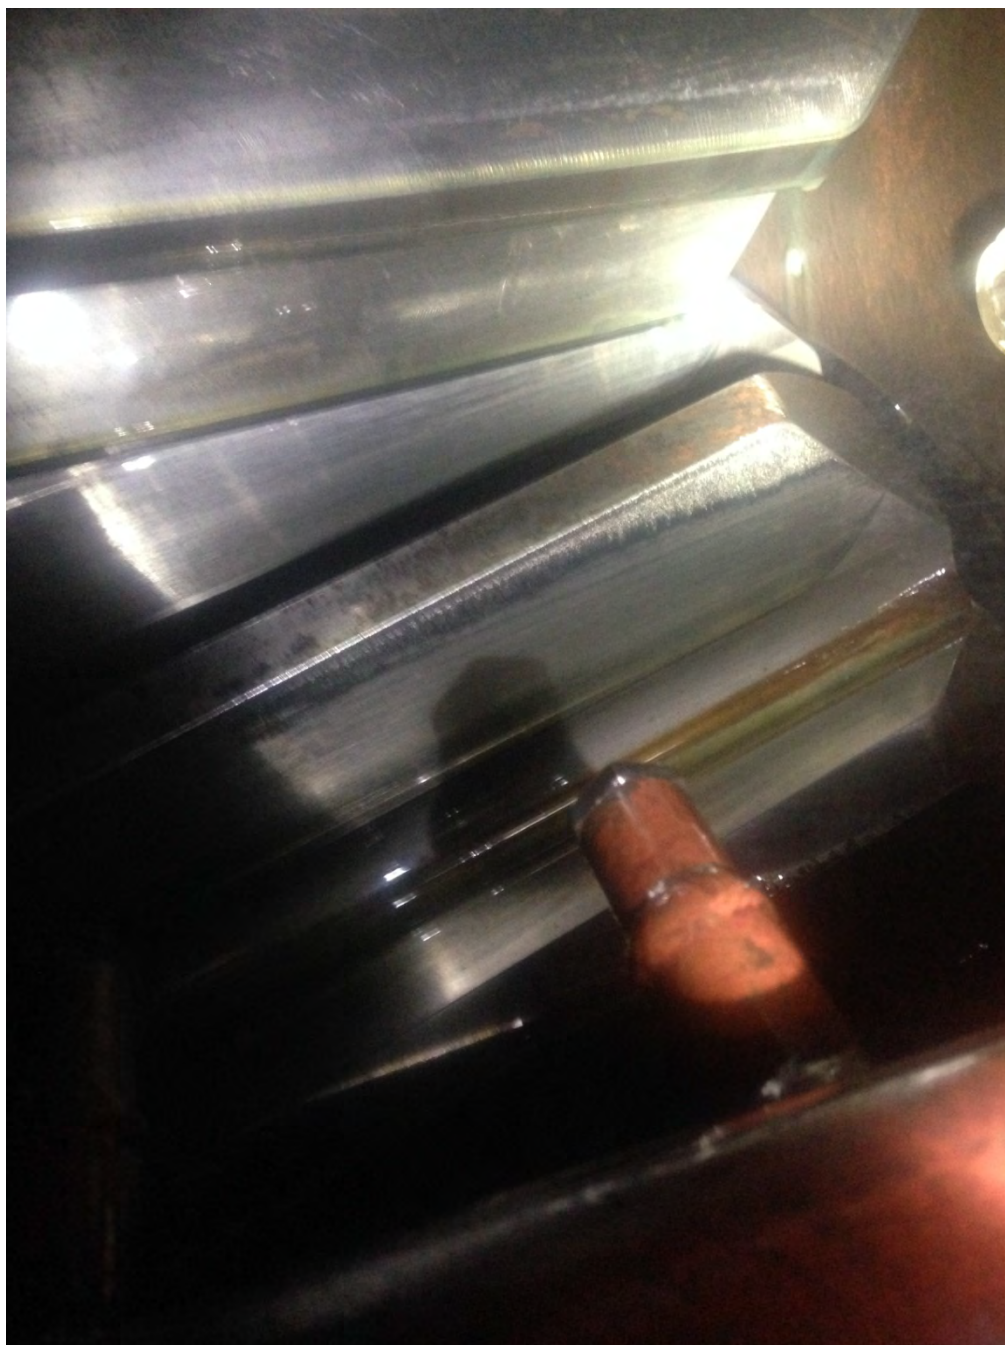
In the following photograph of the **F4 Mesh**, there is clear, drive flank deterioration across approximately 15% of the addendum (top) of the Bottom Pinion Shaft Teeth. This could be insufficient end-relief cut into the new parts. As expected, there is also a noticeable amount of Plastic-flow associated with this deterioration. This was pointed out to Troy and Ron. At some future off-day, Troy will have the top land of this Pinion deburred to remove the edge that is developing across the top land.

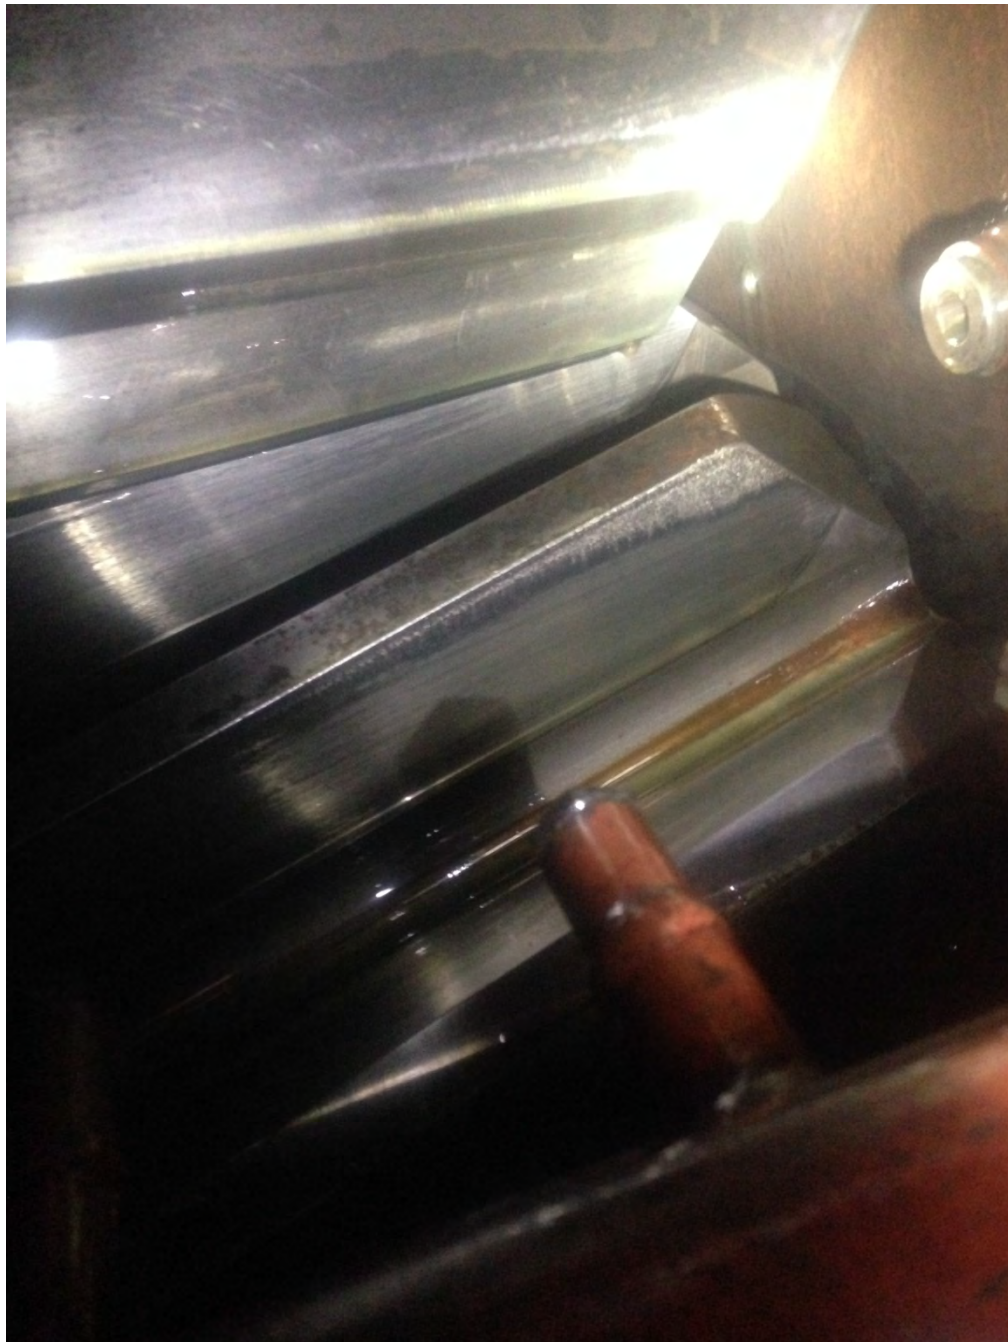
Here is another photograph which also shows the top of the Bottom Pinion deteriorating. We did not observe any corresponding deterioration in the dedendum (below the pitch-line) of the Top Pinion, which is the mating part.

The Teeth on the Bottom Pinion Shaft show noticeable wear. This will be easy to monitor during the next inspection to determine whether or not the deterioration is progressing. We would expect to see the beginning of wear showing up in the corresponding root area of the mating piece. The Bearings of the unit look good with no observable issues.

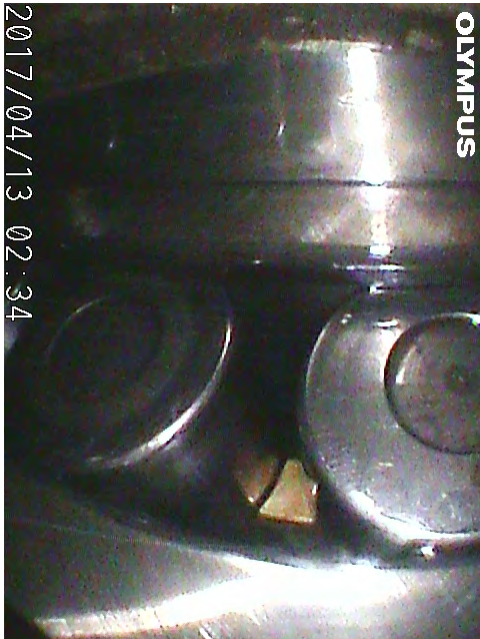
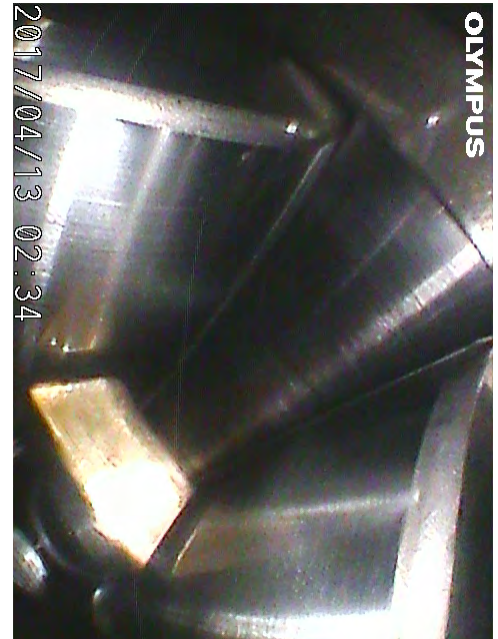
The above photos show **F4 Bottom** (on left) and **Top** (on right) **Motor Side Bearings**.

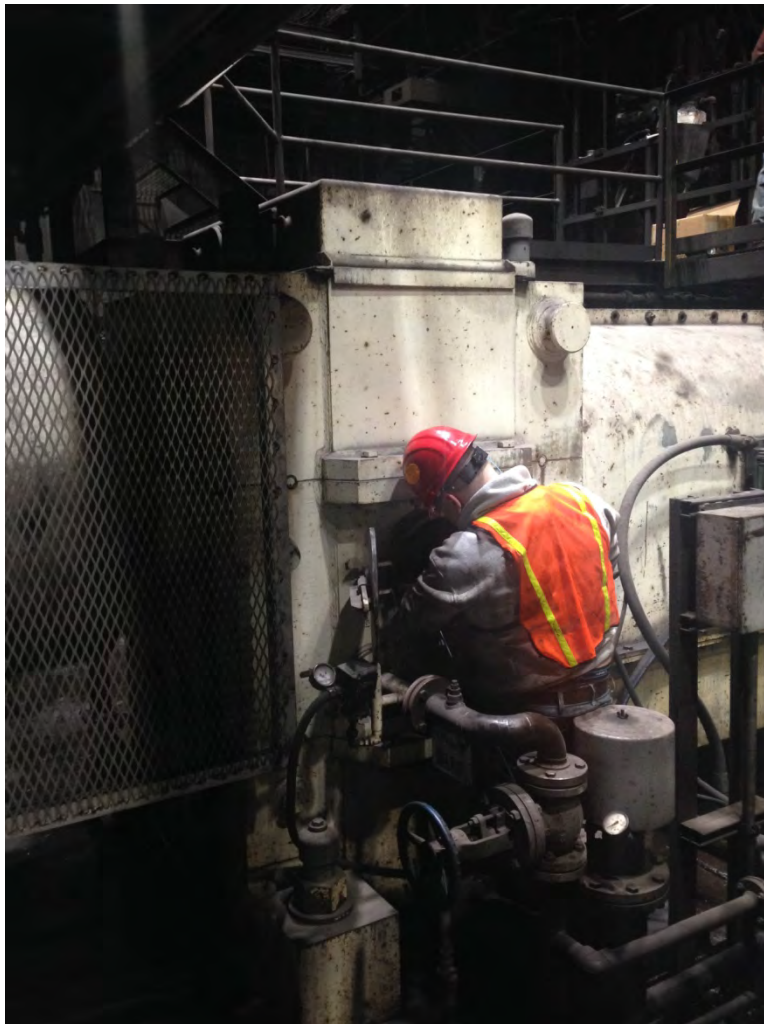
F5 Pinion Stand Gearing: The only remarkable thing to note regarding the teeth, is that there was a mis-machining of the Top Shaft, Mill Side, Drive Flank that resulted in a gouge in each tooth. Obviously, this did not affect the performance of the unit as it continues to run today with that error not with-standing. The Bearings are another story.

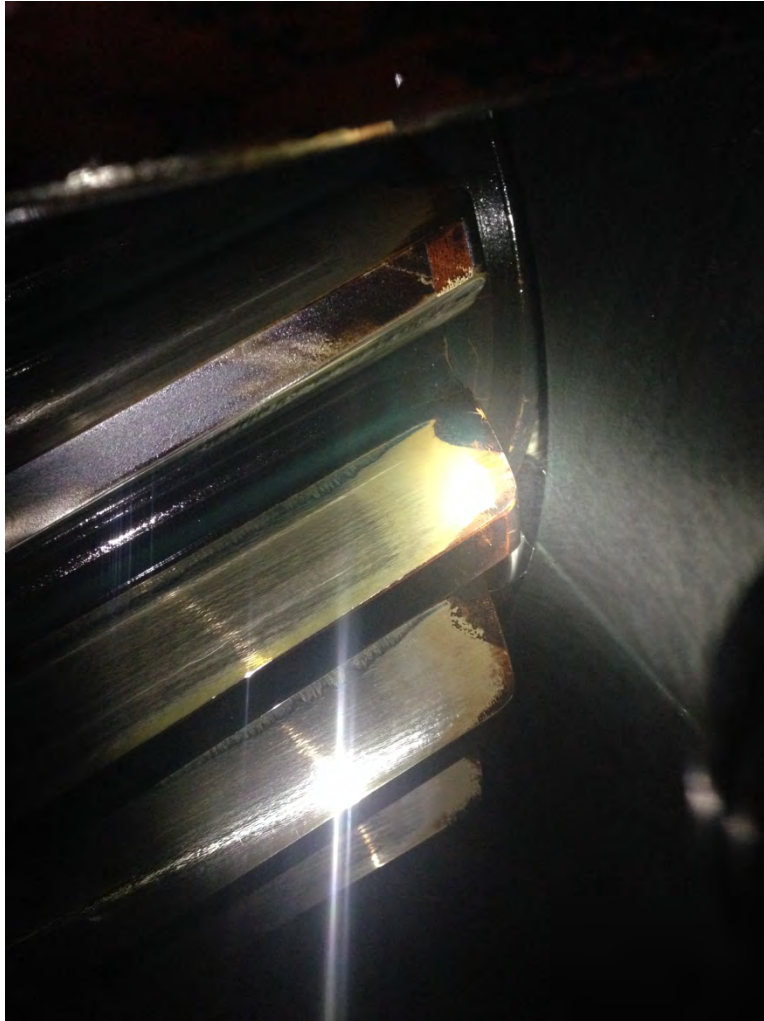
There is obvious wear in the tip and root areas of the teeth but nothing that is out of the ordinary or unexpected. No pitting or spalling or severe plastic-flow was detected. It appears as if the tips of these teeth have been re-deburred at some point (or points) in the past.

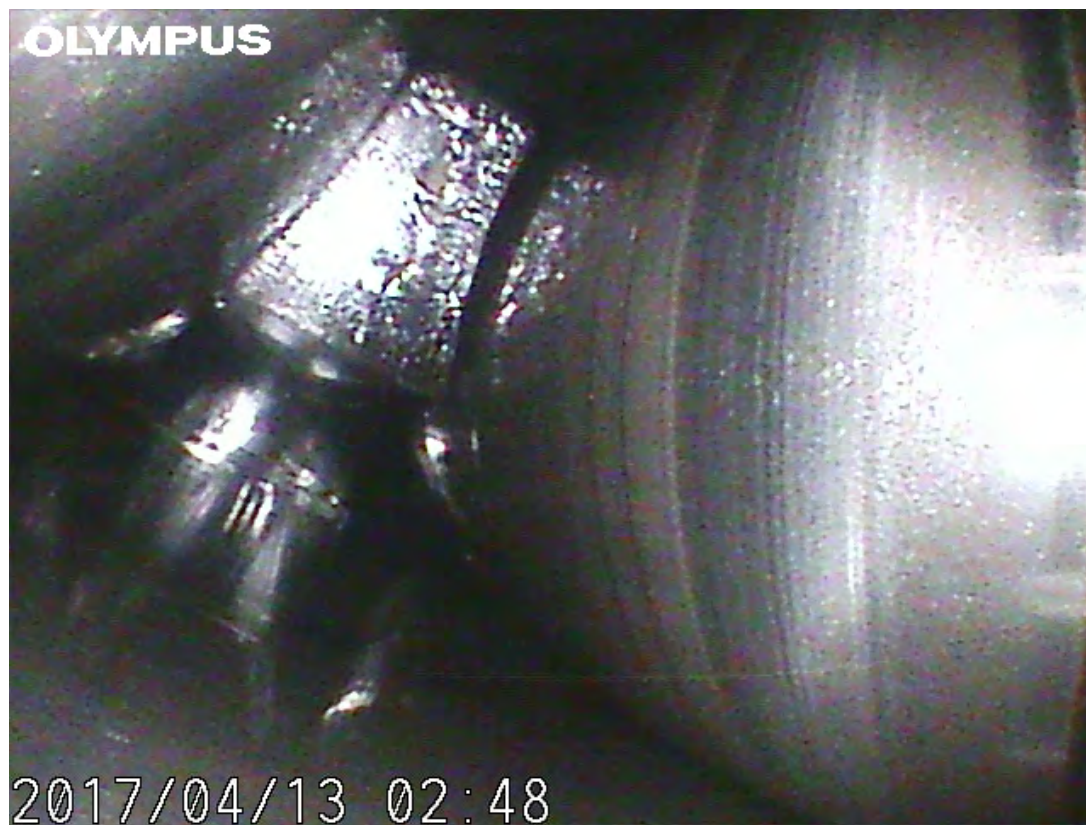
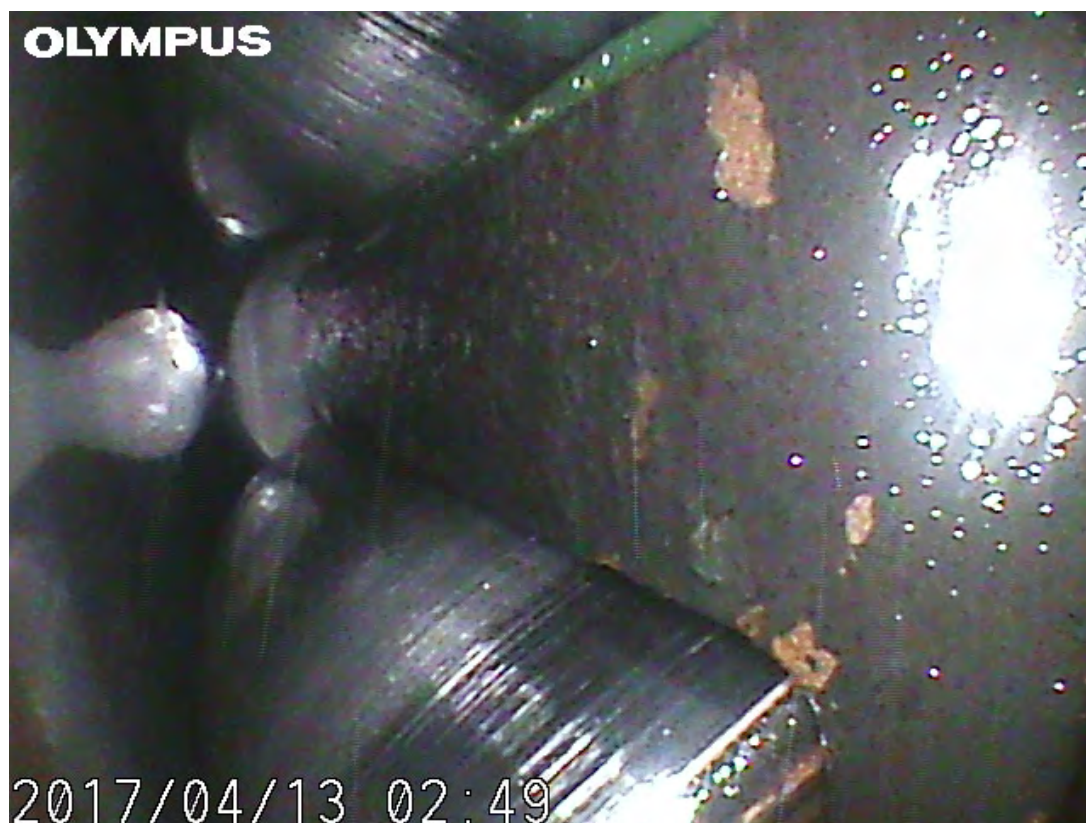
F5 Pinion Stand Bearings: All four of the Bearings are Rough. This page shows the Motor Side Bearings; first the Bottom Shaft and second the Top Shaft.

All **F5 Pinion Stand Bearings** display significant wear with quite visible grooves worn into the rollers. These need to be on the list for change-out during an upcoming outage.

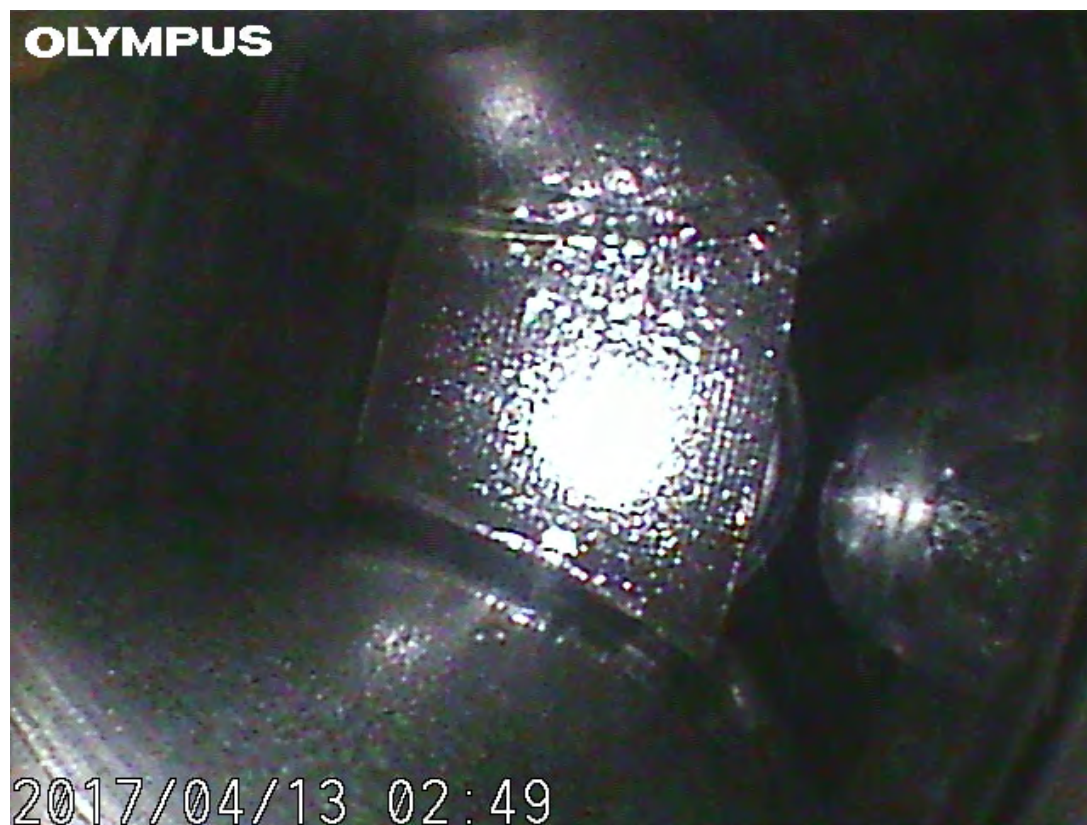
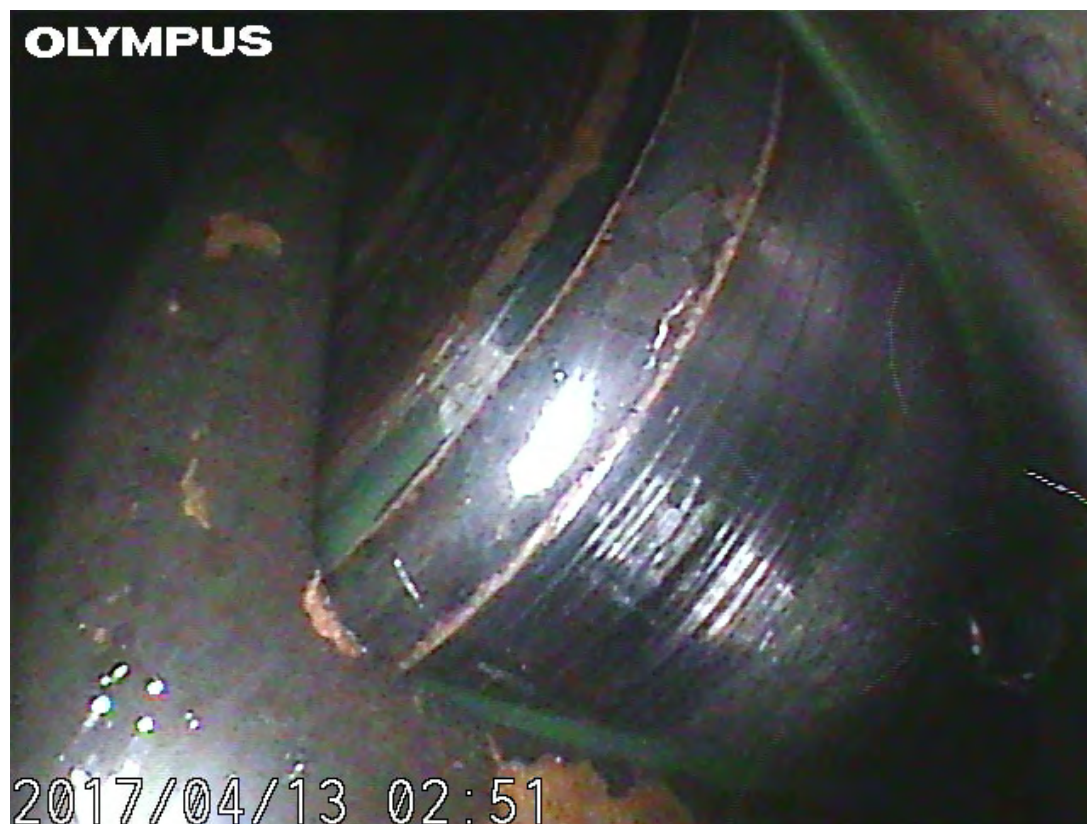
This page shows the F5 Mill Side Bearings; first the Bottom Shaft then, second, the Top Shaft.
