Inspection of Selected Gear Reducers

ABC Steel – Anytown, IN Hot Mill

Work performed April 12, 2017
ABC Steel Purchase Order # **xxxxxxx**
Cage Gear Project # **1704011**

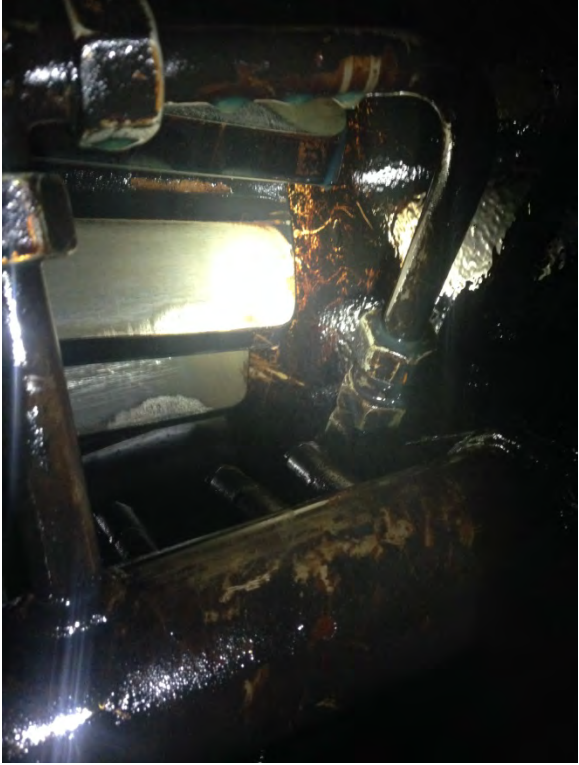
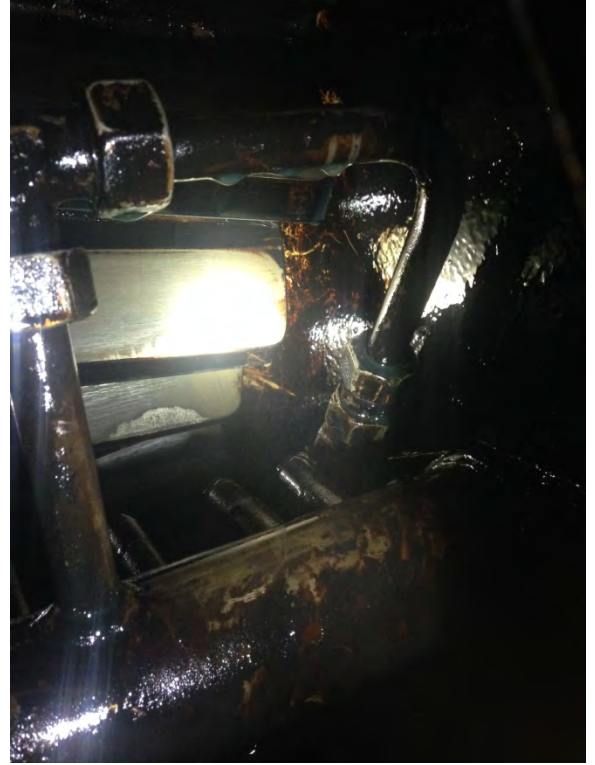
These photographs show the wear on the **F6 Top Pinion Shaft** approximately 10-15% across the top of the drive flank, from the top land to about half way to the pitch-line, on the Mill Side of the unit.

This unit's Gear Teeth display some obvious wear which can be monitored and addressed as required. The Bearings appear to be in satisfactory condition. The unit is not in danger of catastrophic failure any time in the near future.

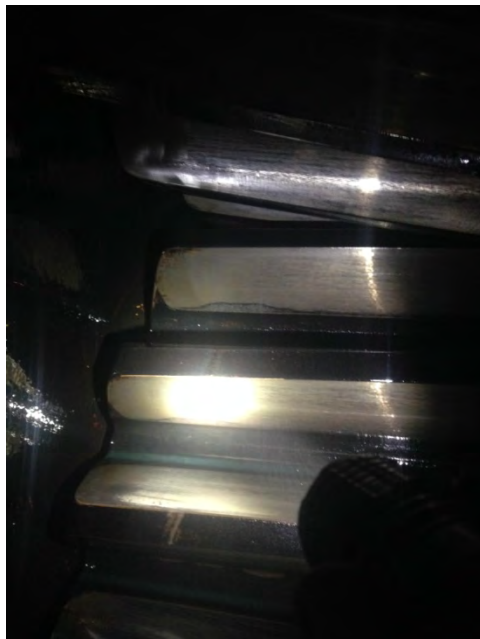
This photograph shows corresponding wear in the root area of the **F6 Bottom Pinion Shaft**.

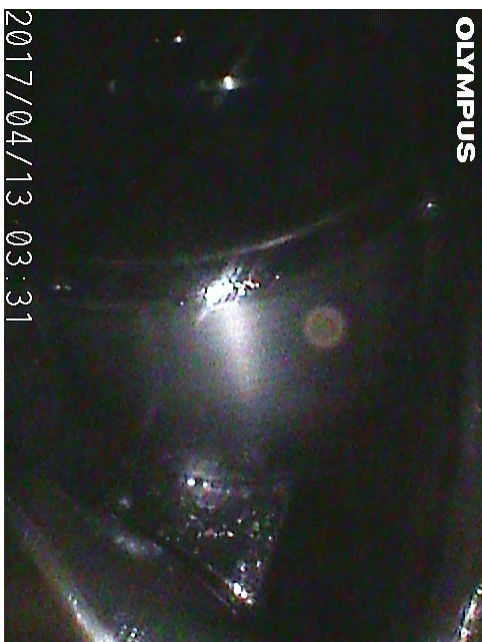
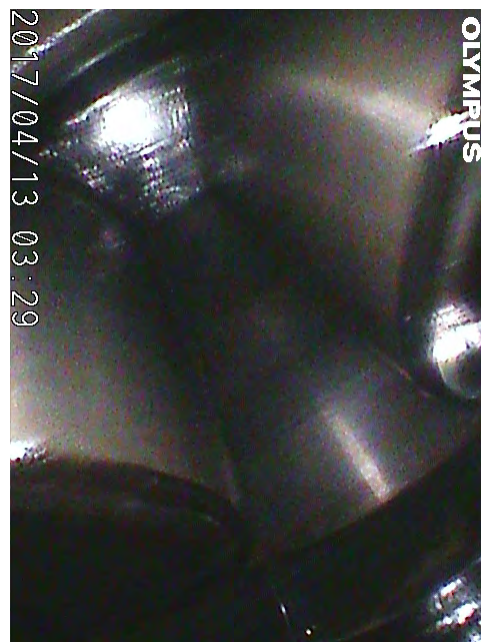
F6 Pinion Stand Motor Side Bearings; Bottom Shaft (on left) and **Top Shaft** (on right).

F6 Pinion Stand Bearings: There were no significant problems detected.

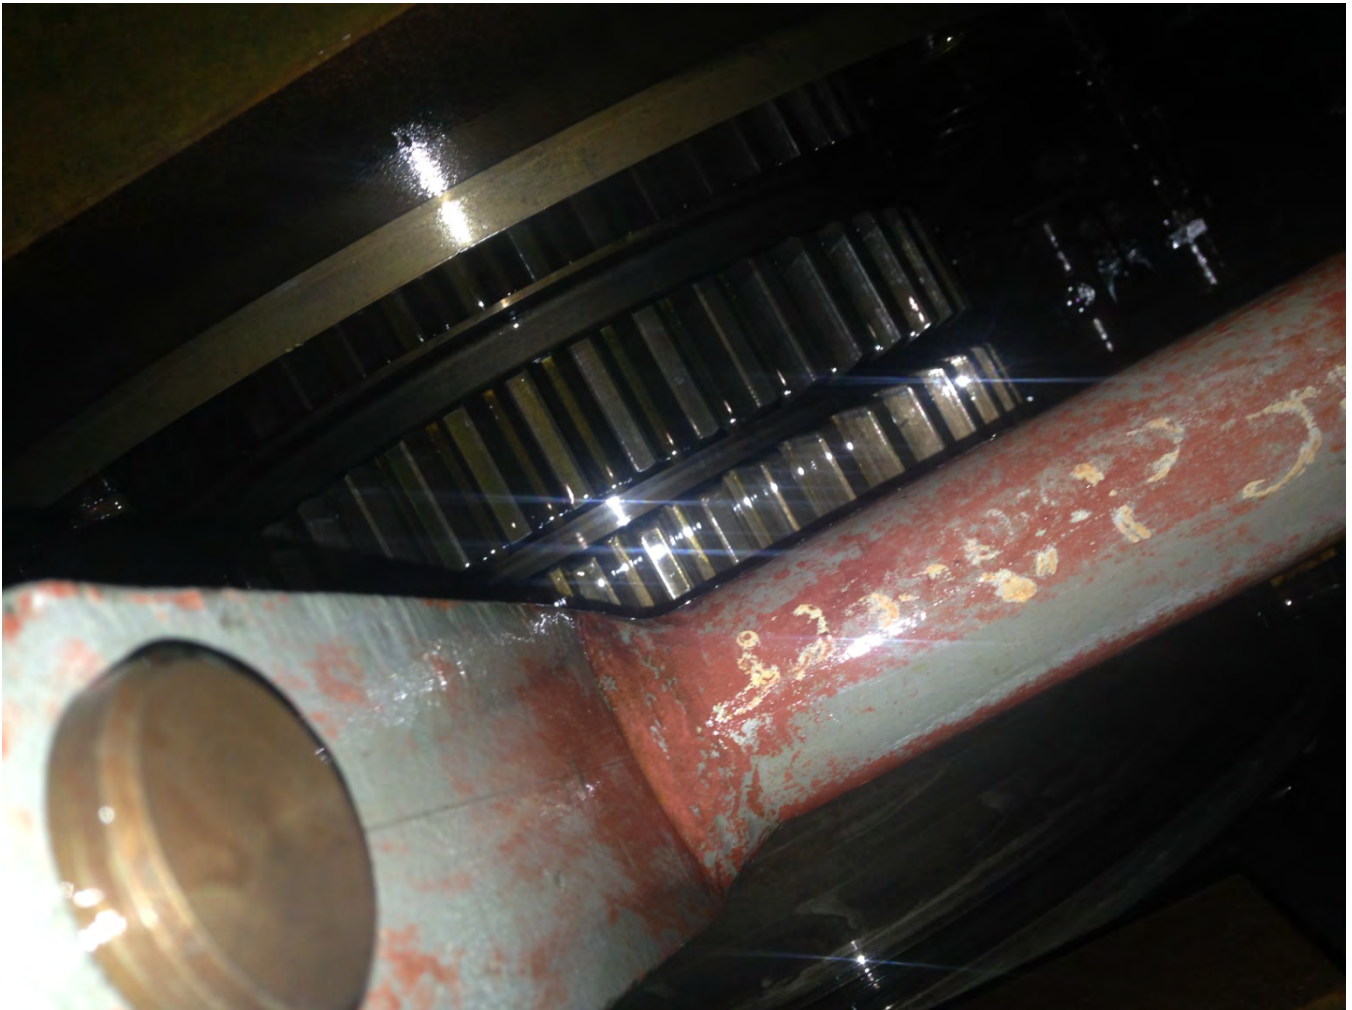
Coiler #1 Change Gearing

From the limited vision field we could see, we detected no issues with the Gearing or Bearings that we could view of this unit.

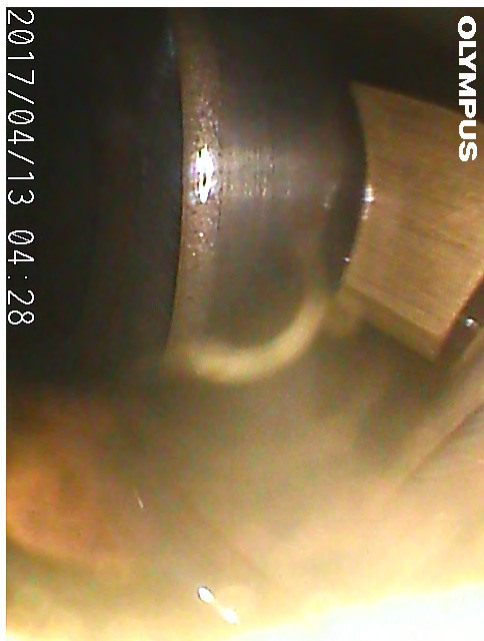
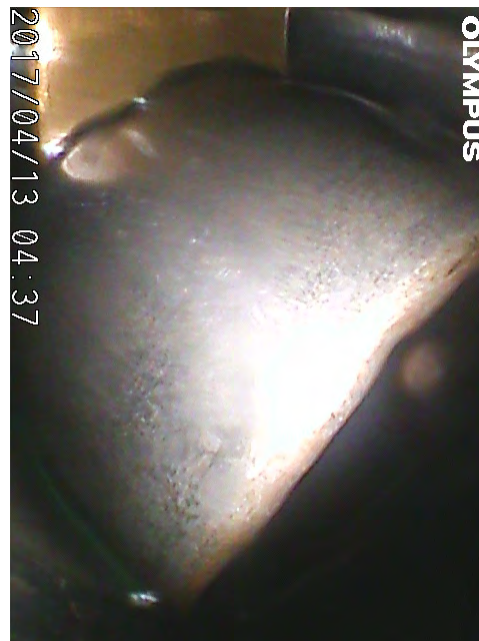
Coiler #1 Top Shaft Bearing

These photographs are representative of the view that we had of the Top Shaft Bearing on Down Coiler #1. There were no visible discrepancies that we noted during our visit to this unit.

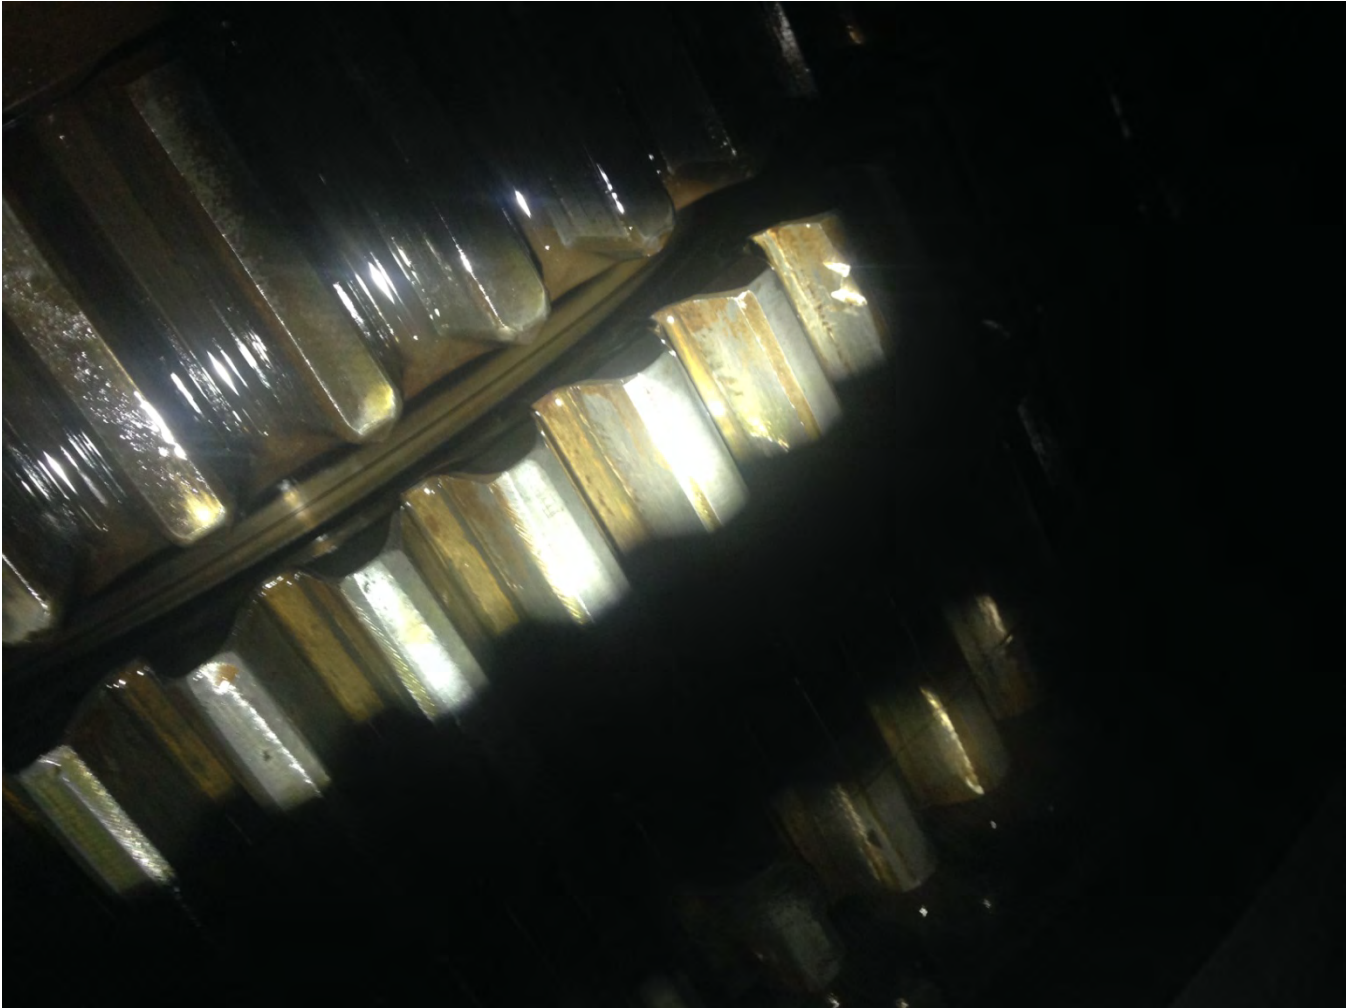
On this unit, although we still could not perform anything other than a cursory inspection, we did see issues with the Change Gearing Teeth and we saw what appeared to be scratches on the Top Shaft Bearing.

Although the photographs are not terrific, because the damage was not directly under the inspection cover on top of the unit, looking at the TOP LEFT, and at the farthest teeth to the RIGHT on the next two rows of teeth, it appears that something has gone through mesh within this unit as the top lands of those teeth are show non-uniform damage.

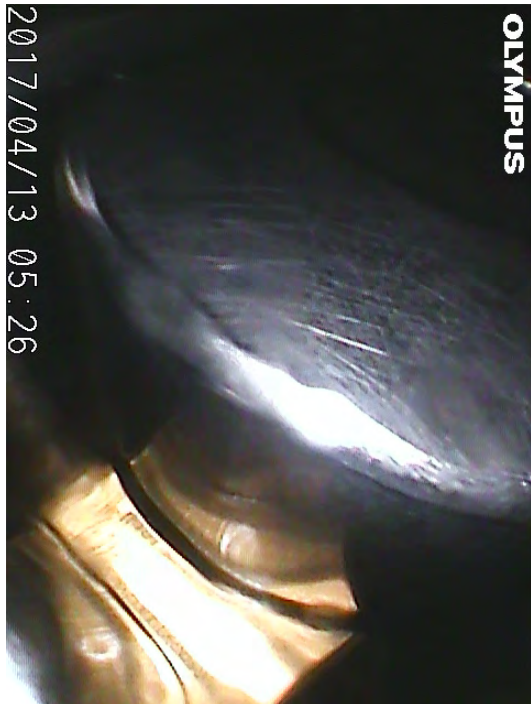
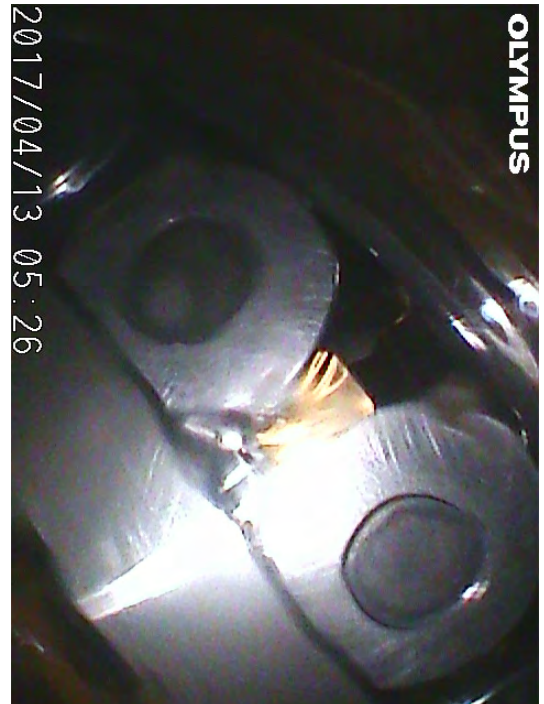
Down Coiler #2 Top Shaft Bearing. Note the Scratches. Something going through mesh ?

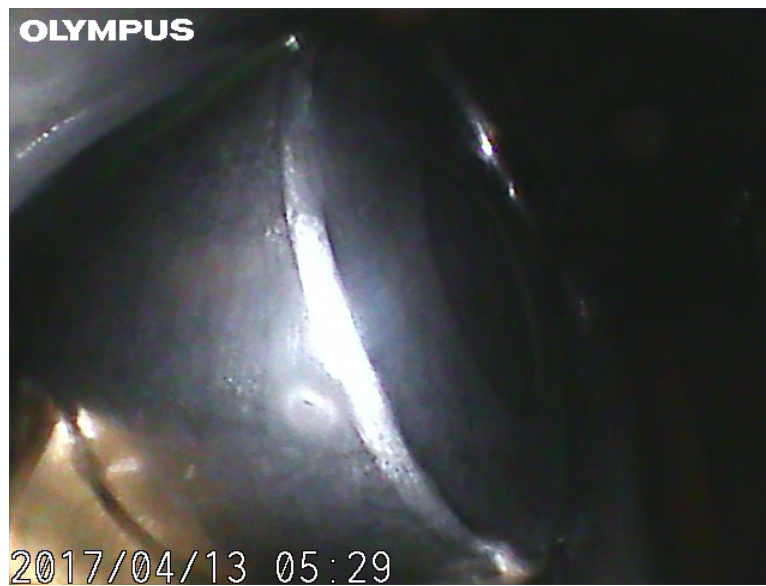
The Roller Surfaces look fine but the sides appear scratched.
