Inspection of Selected Gear Reducers

ABC Steel – Anytown, IN Hot Mill

Work performed April 12, 2017
ABC Steel Purchase Order # **xxxxxxx**
Cage Gear Project # **1704011**

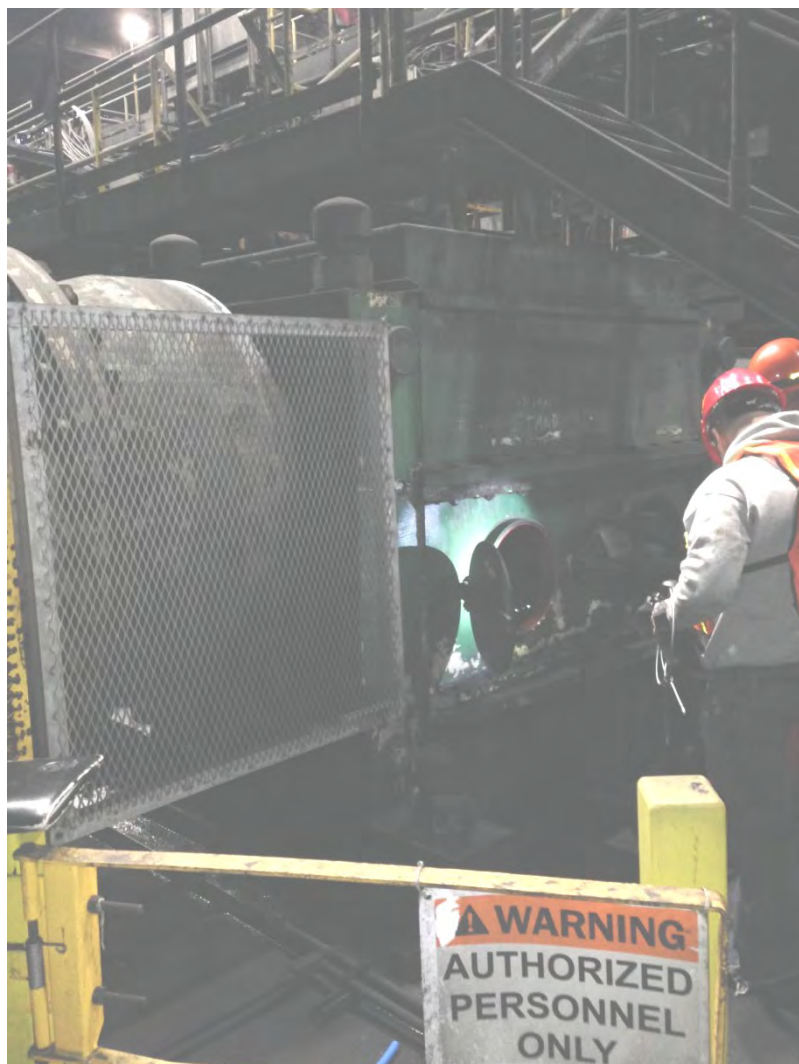
F1 Pinion Stand

This was the first unit inspected. (The Motor Room is to the left.)

The first thing noted was the seemingly large amount of leakage and pools of oil around the unit. Upon further inspection, for the most part the bores and splits of the housing look okay. The suspicion is that the oil is seeping, when the unit is in operation, from the access doors on either side of the unit. An enhanced sealing system would likely reduce the amount of leakage from this unit.

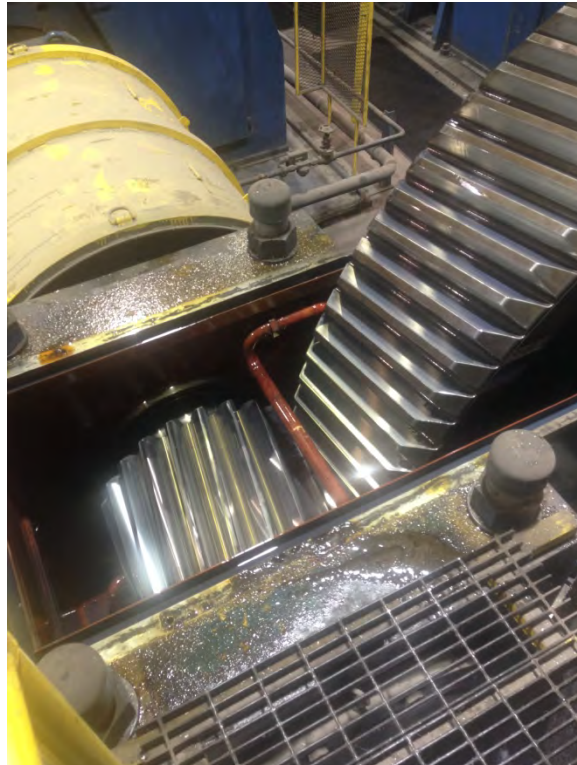
#1 Main Drive

This is an SMS Single Reduction Gear Reducer in the Motor Room driving F1 Pinion Stand. This is the next unit we inspected.

The Gear Mesh looked good with well proportioned contact between the elements.

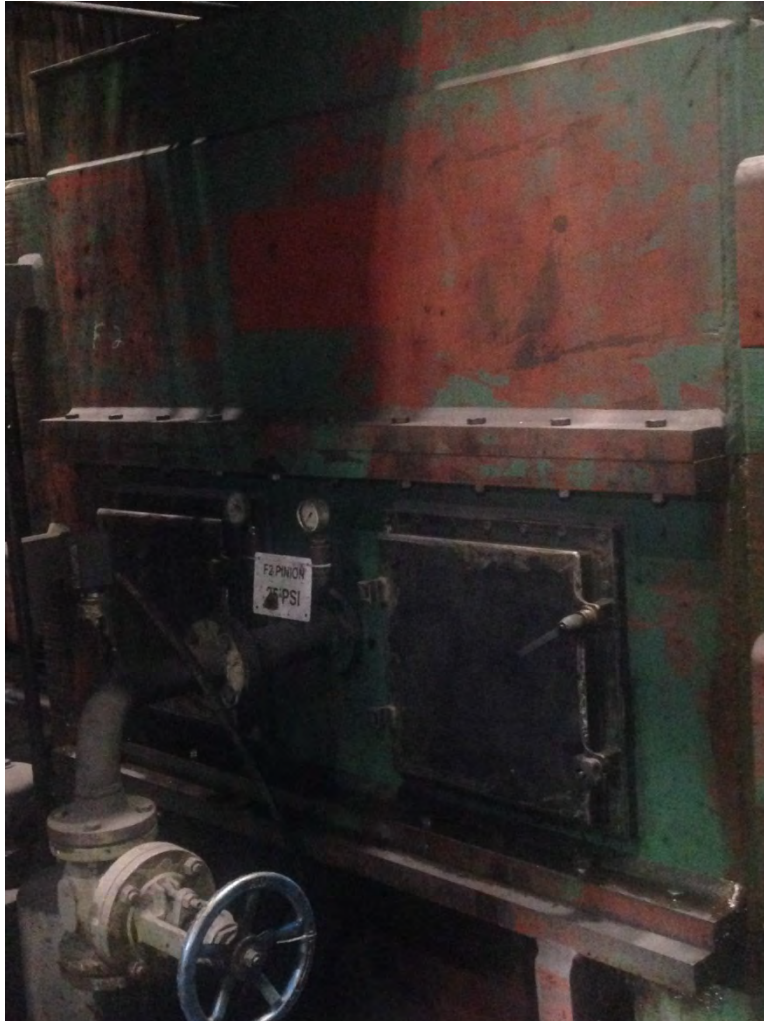
F2 Pinion Stand

This unit displayed leakage similarly to the F1 Pinion Stand, just not as bad. The teeth on this unit also showed good contact and normal, expected wear. For some reason, there was a degree of discoloration associated with the teeth of both elements. Generally that indicates a “heat” issue but there were no other signs indicating issues. We detected no pitting, spalling or even plastic-flow on either the top or bottom Pinion Shaft.

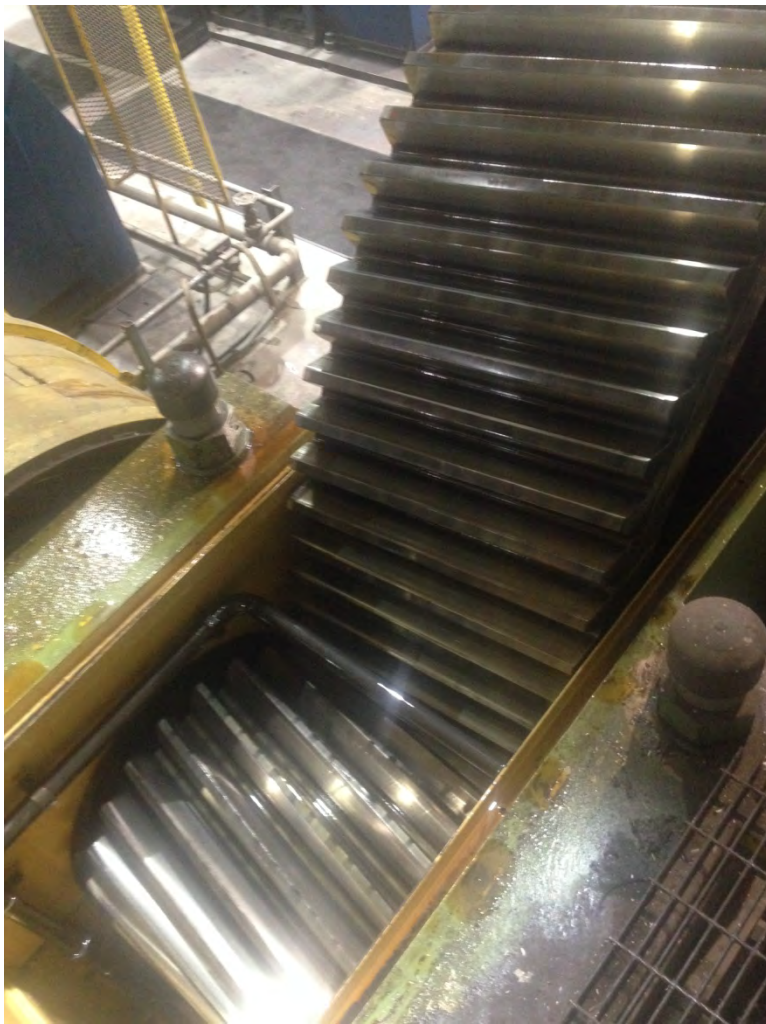
#2 Main Drive

This also is a Single Reduction Gear Reducer in the Motor Room driving F2 Pinion Stand.

Both the RH Helical Pinion Shaft and the LH Helical Gear Teeth of this unit look good with no signs of deterioration.

With regard to the **Main Drive # 2** Bearings, both of the Gear Bearings look good with no noticeable issues. The Pinion Shaft Motor Side Bearing also looks good with no issues. However, the **Pinion Shaft Mill Side Bearing** shows signs of early deterioration as the photographs below show.

As with the #1 Main Drive, the gear teeth of both of these elements both look as if they possess a significant amount of remaining useful life. While we do not believe that catastrophic failure is imminent, this Pinion Shaft Mill Side Bearing should also be addressed sooner rather than later. Again, we will look at this next time as well.

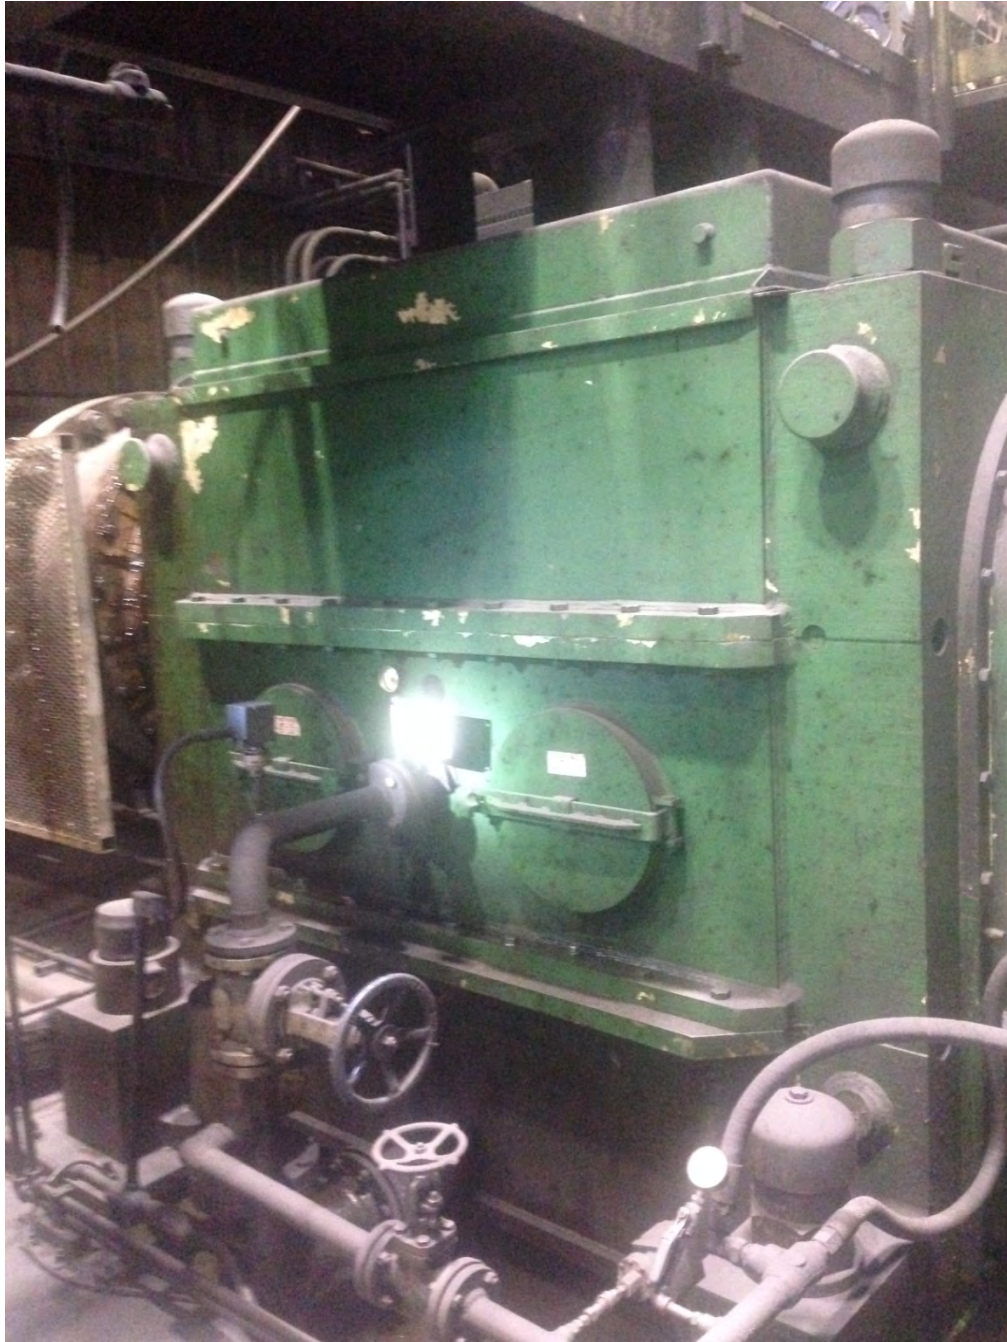
F3 Pinion Stand

The Teeth and the Bearings in this unit all look as they should with good, full contact between the elements. No issues were observed during our inspection.

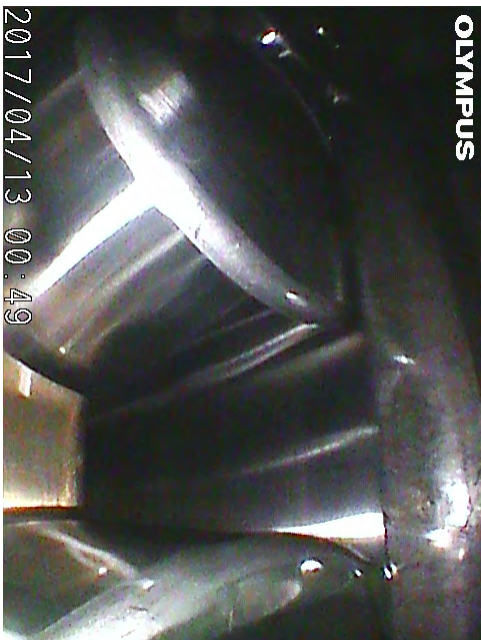
F3 Pinion Stand Bottom (on left) and Top (on right) Motor Side Bearings.

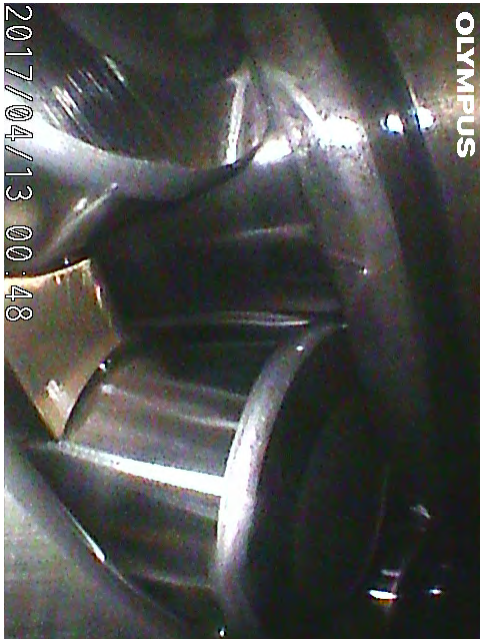
F3 Pinion Stand Bottom (on left) and Top (on right) Mill Side Bearings.

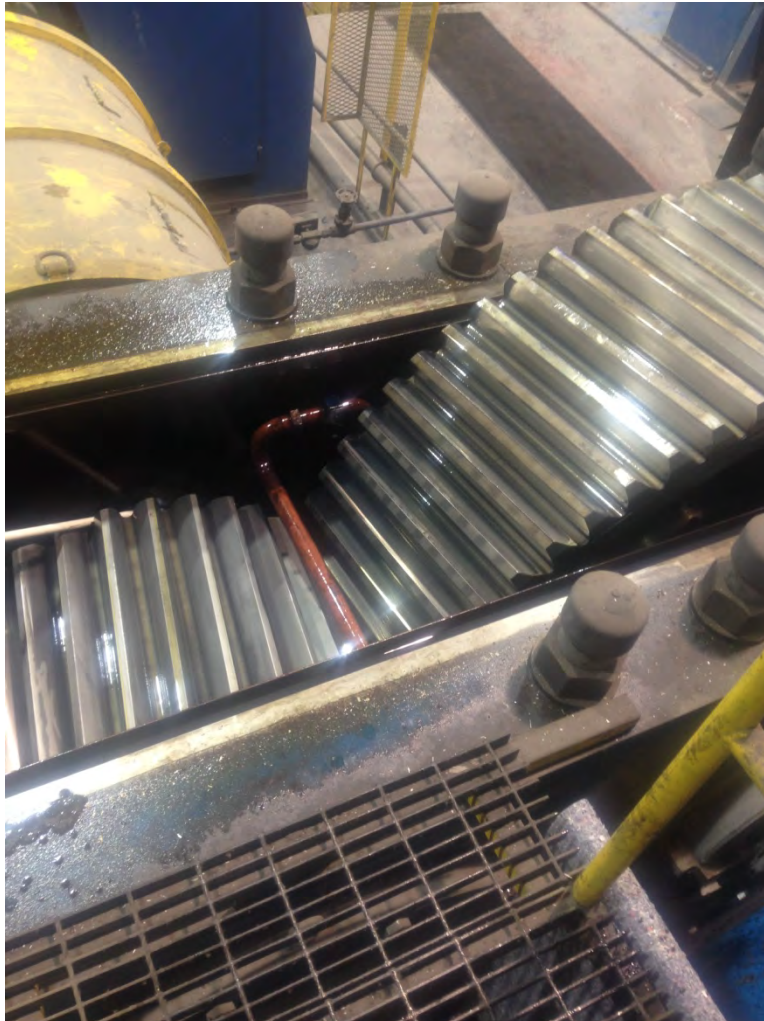
#3 Main Drive

This also is a Single Reduction Gear Reducer in the Motor Room driving F3 Pinion Stand.

The gear mesh between the RH Helical Pinion Shaft and the LH Helical Gear Teeth of this unit looks good with no signs of any issues or deterioration.

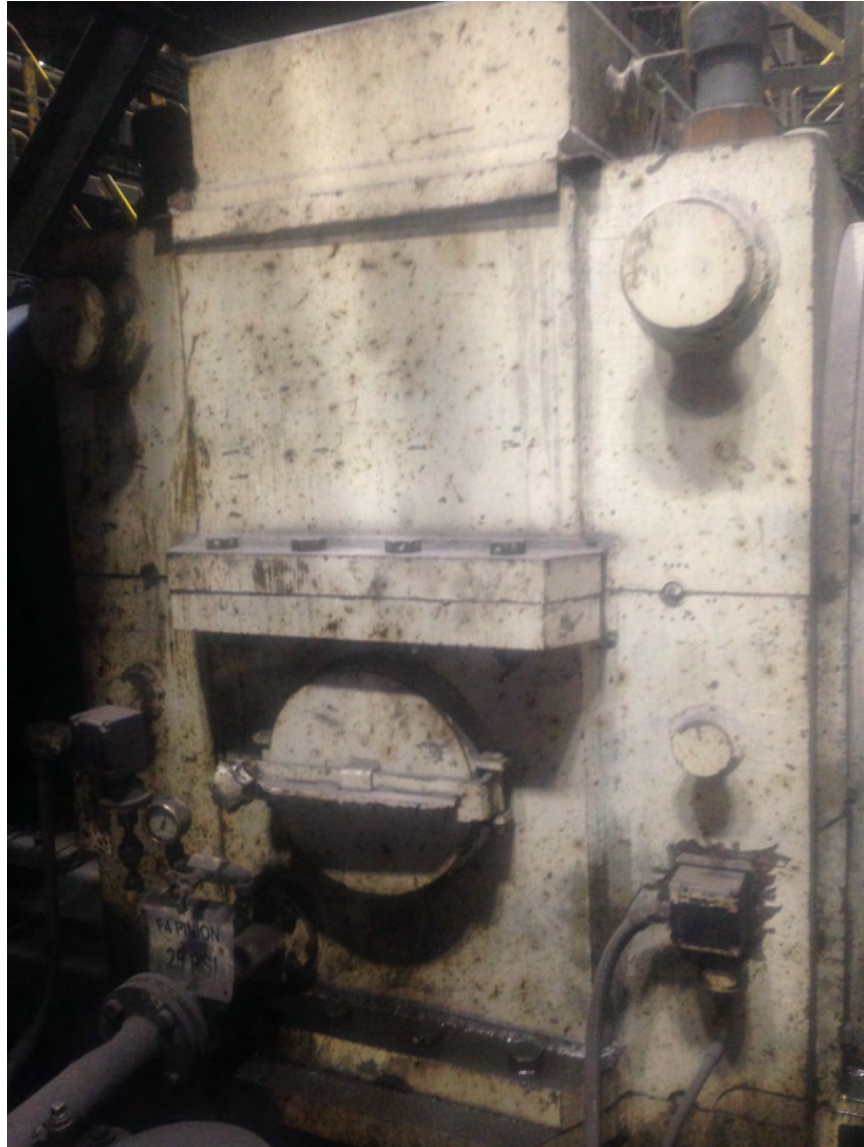
F4 Pinion Stand

The Pinion Shafts in this unit, as well as in the F5 and F6 Pinion Stands, are Single Helical Pinion Shafts as opposed to Double Helical design as seen in the first three units.

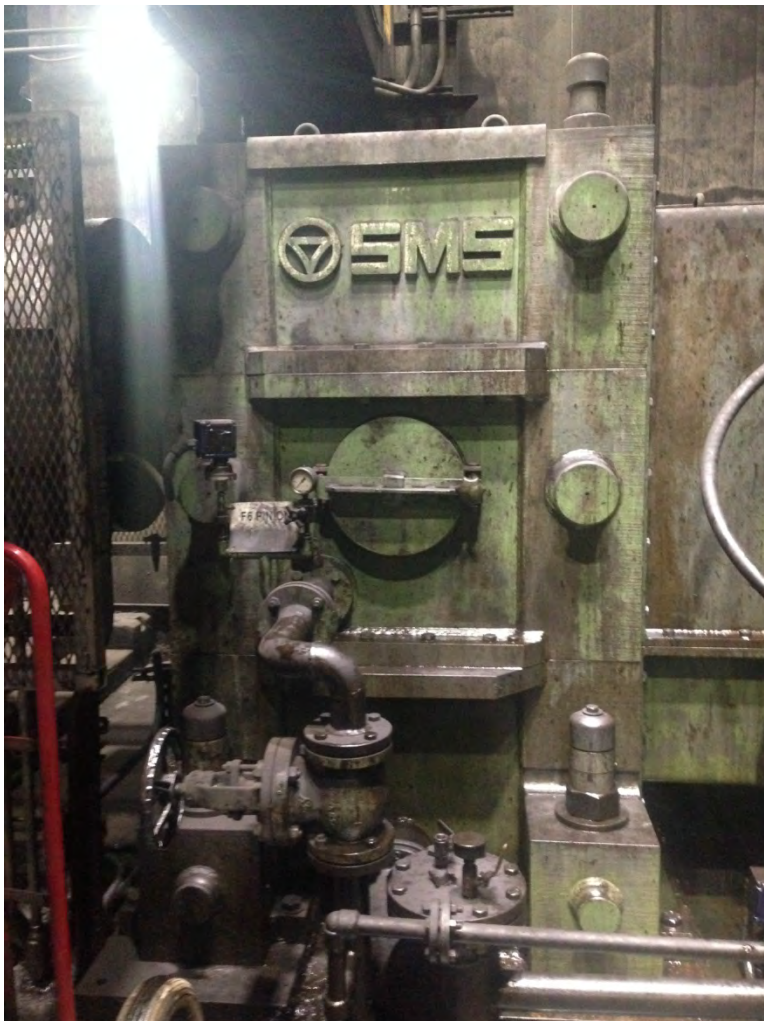
F6 Pinion Stand

The Teeth on both the Top Pinion and the Bottom Pinion display areas of wear and deterioration. The Bearings all appear to be in satisfactory condition. The following photographs document conditions found.

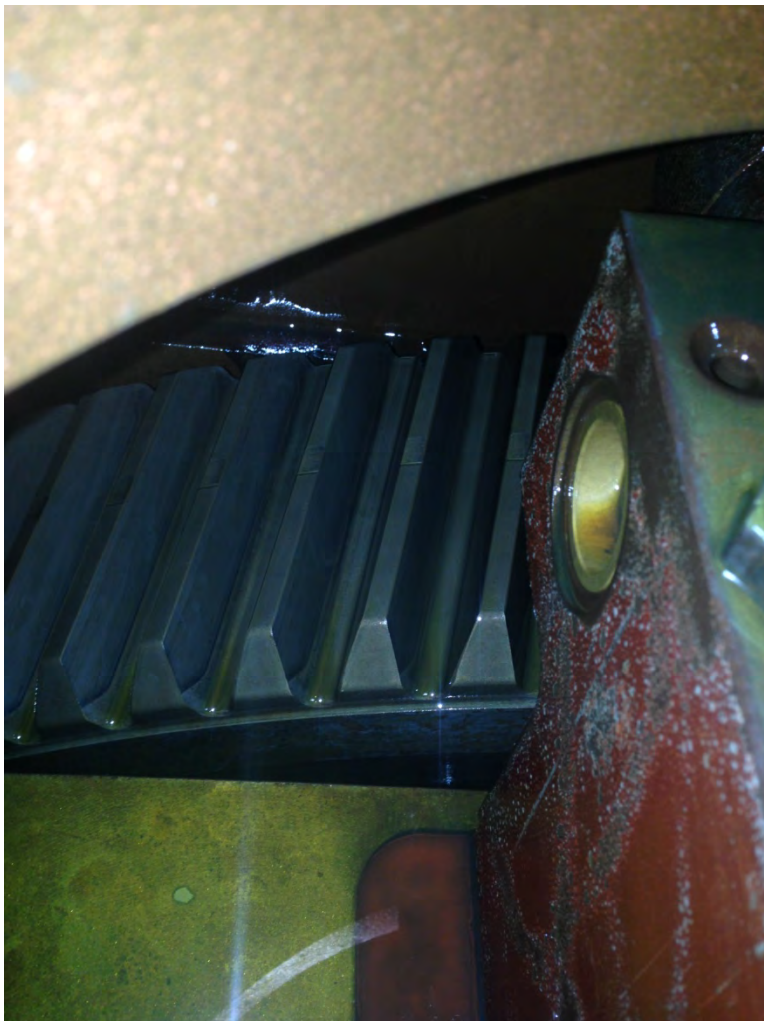
Top Gear

We were able to see very little of the Coiler parts. The units were filled with oil which prohibited us from any Bore Scope photos of any items below the oil levels. Basically, we could only see an approximately 30 degree arc of the top gear teeth; a similar section of the top of the Change Gear Teeth and the Top Shaft inside Bearing.

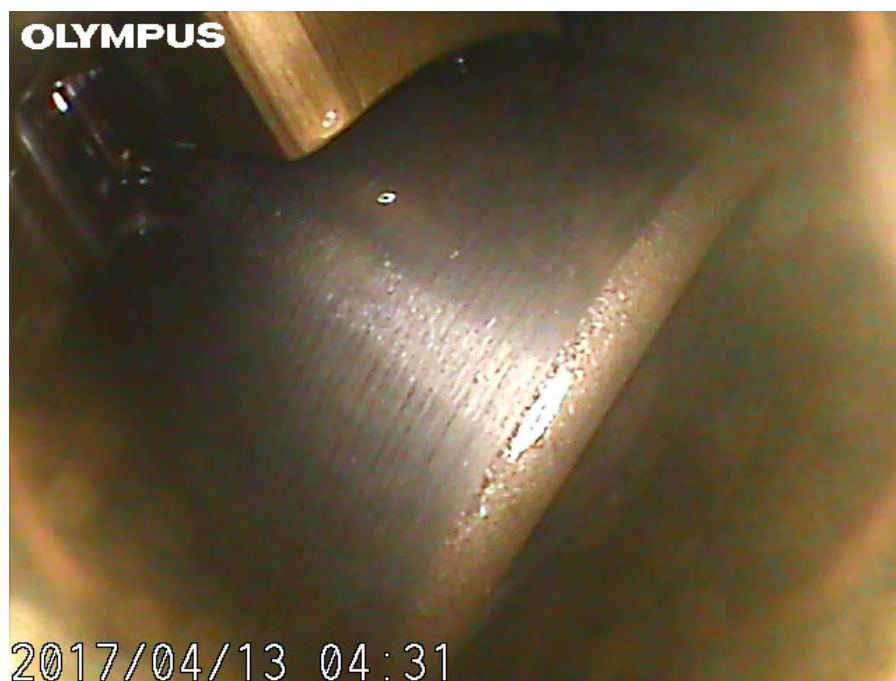
These photographs are representative of the view that we had of the Top Shaft Bearing on Down Coiler #1. There were no visible discrepancies that we noted during our visit to this unit.
